Panoramic Near-Infrared Camera

# Performance of the HAWAII-4RG Detector for PANIC-4K

Vianak Naranjo, 18.07.2022

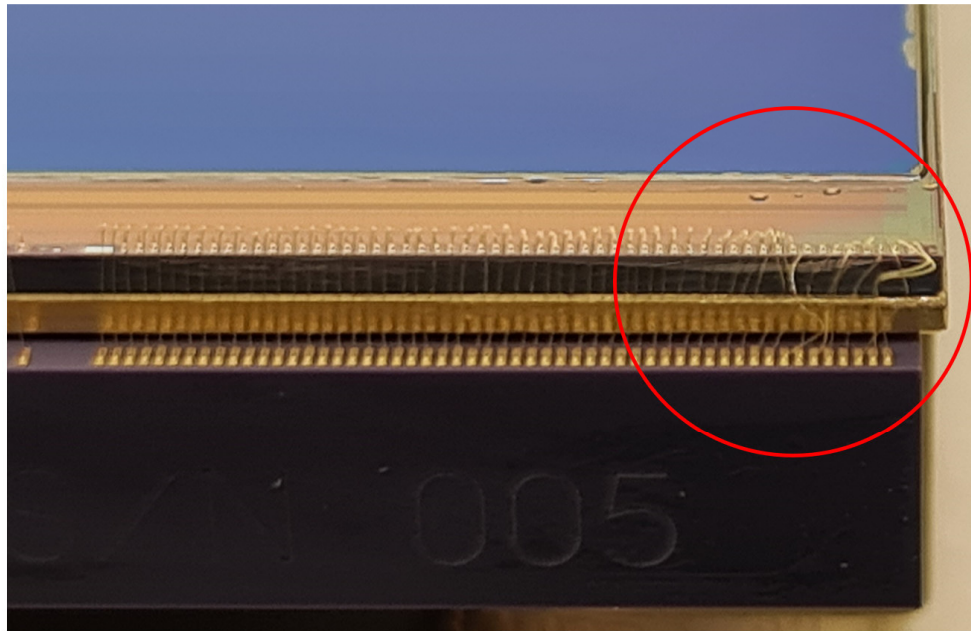
- Some wirebonds were bent during integration

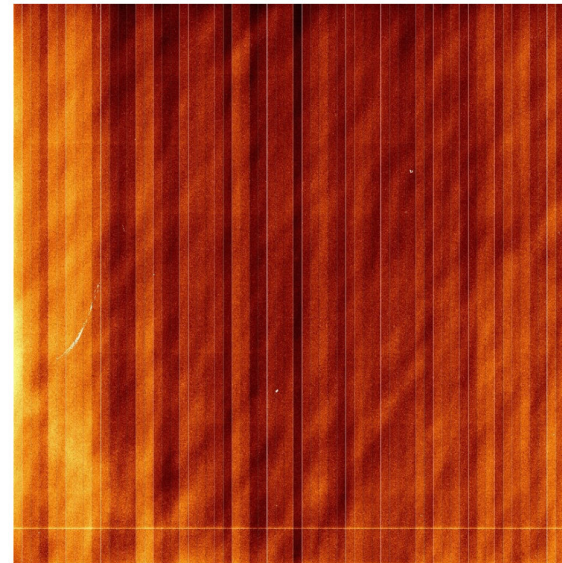
- Some wirebonds were bent during integration
- Repositioned by MPIA Team and warm tests successful
- Cold tests revealed no detector signal
