PANIC – REACTIONS AFTER CRYOSTAT LEAK

Bernhard Dorner, 27 March 2015
MPIA AstroTechTalk

The accident: what

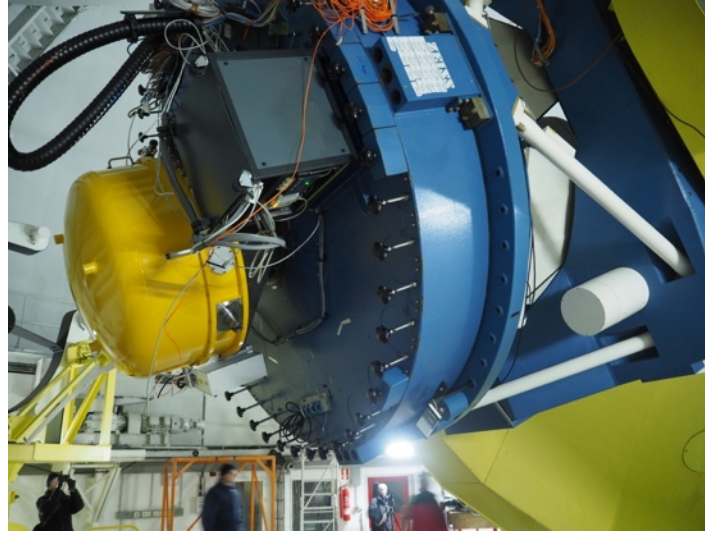
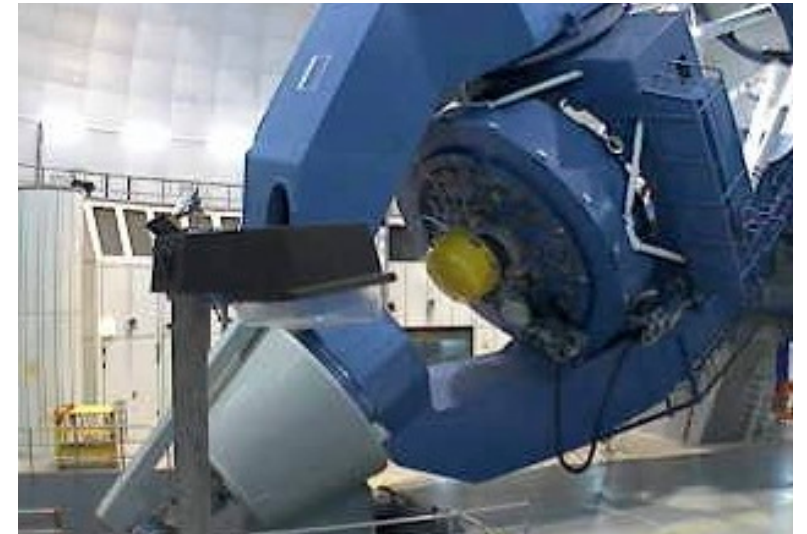
Telescope	2.2m	3.5m
FOV	30'×30'	15'×15'
Pixel scale	0.45''	0.225''
Detectors	2×2 mosaic of H2RG 2k×2k	
Filters	Z,Y,J,H,Ks; H2 (expandable)

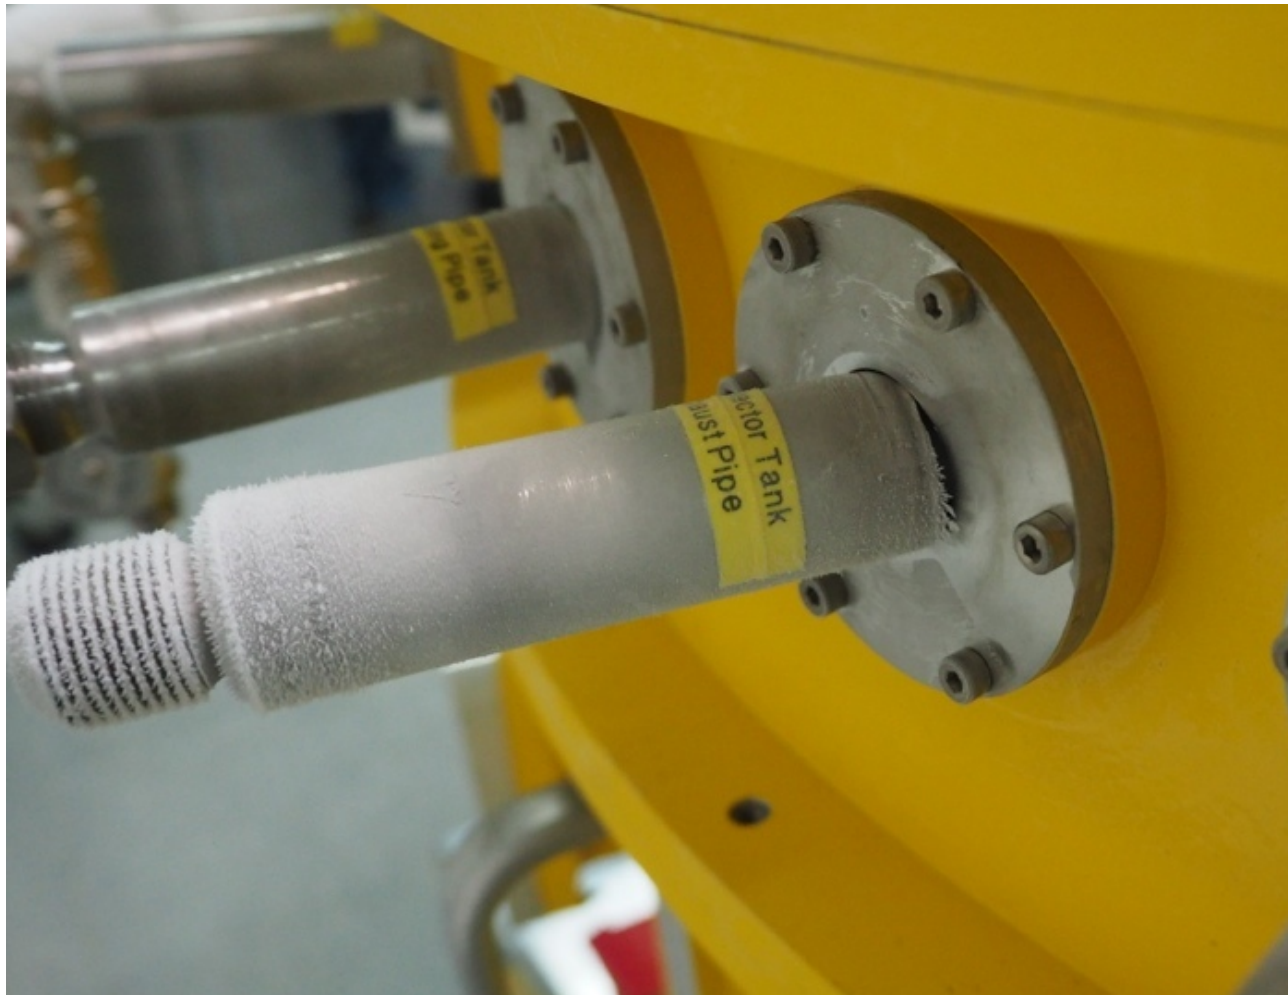
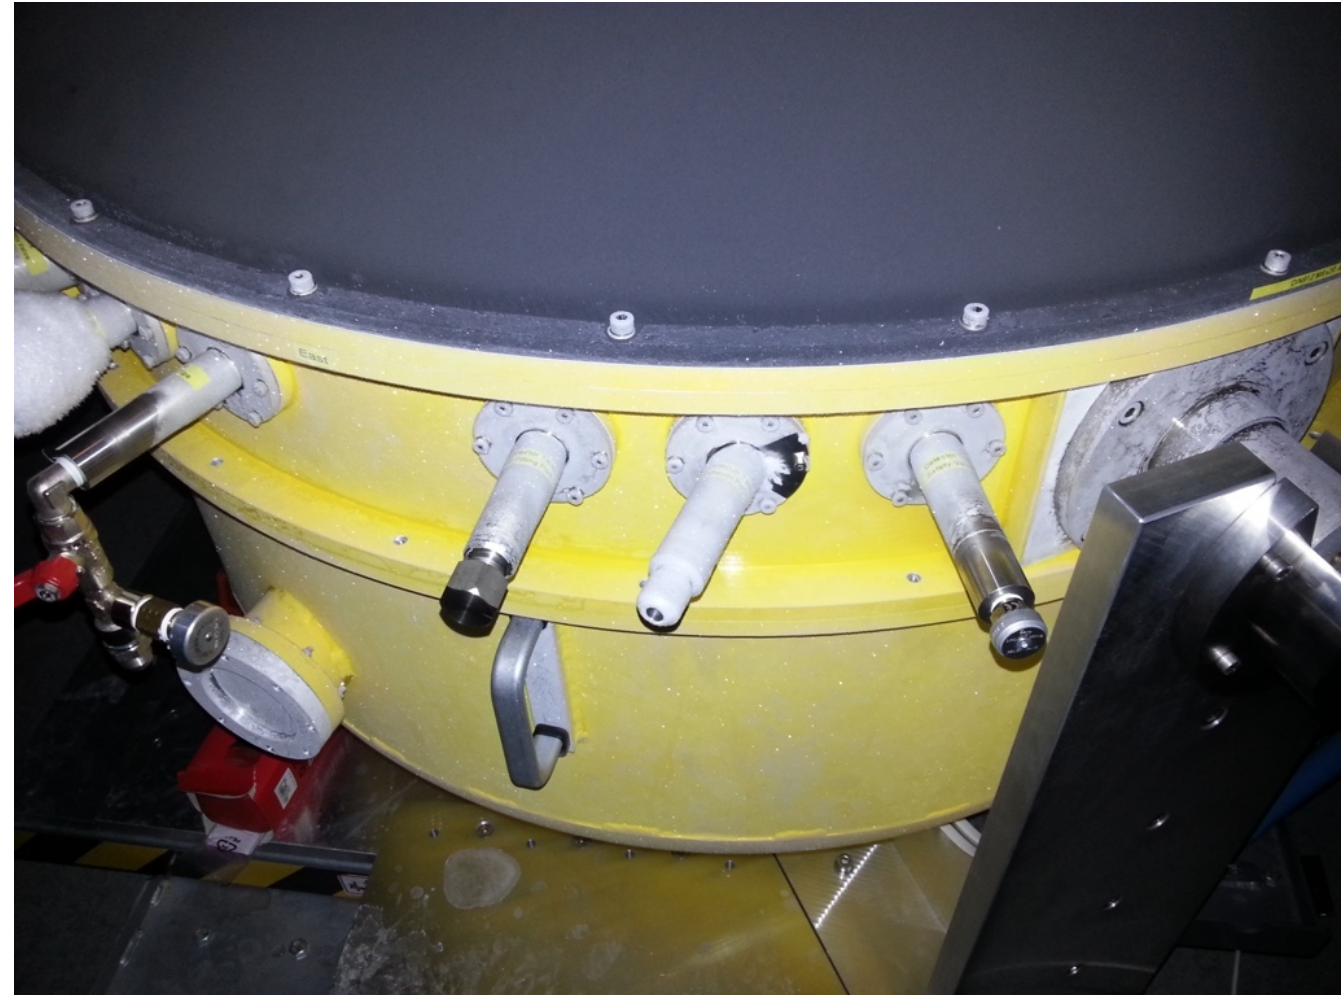
- Nitrogen exhaust pipe torn from flange: leak in cryostat
- Vacuum loss within few minutes
- Air in instrument, warming up, outside later frozen

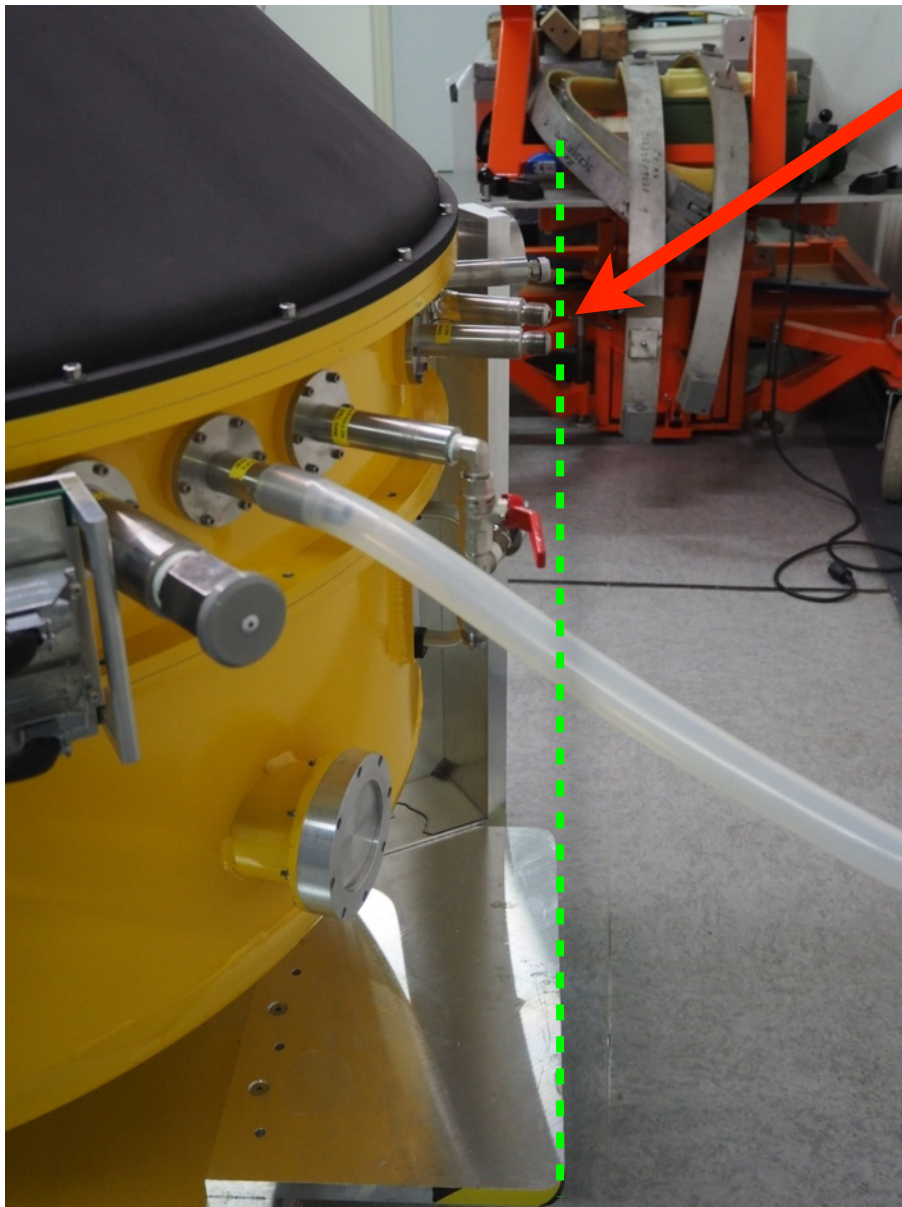
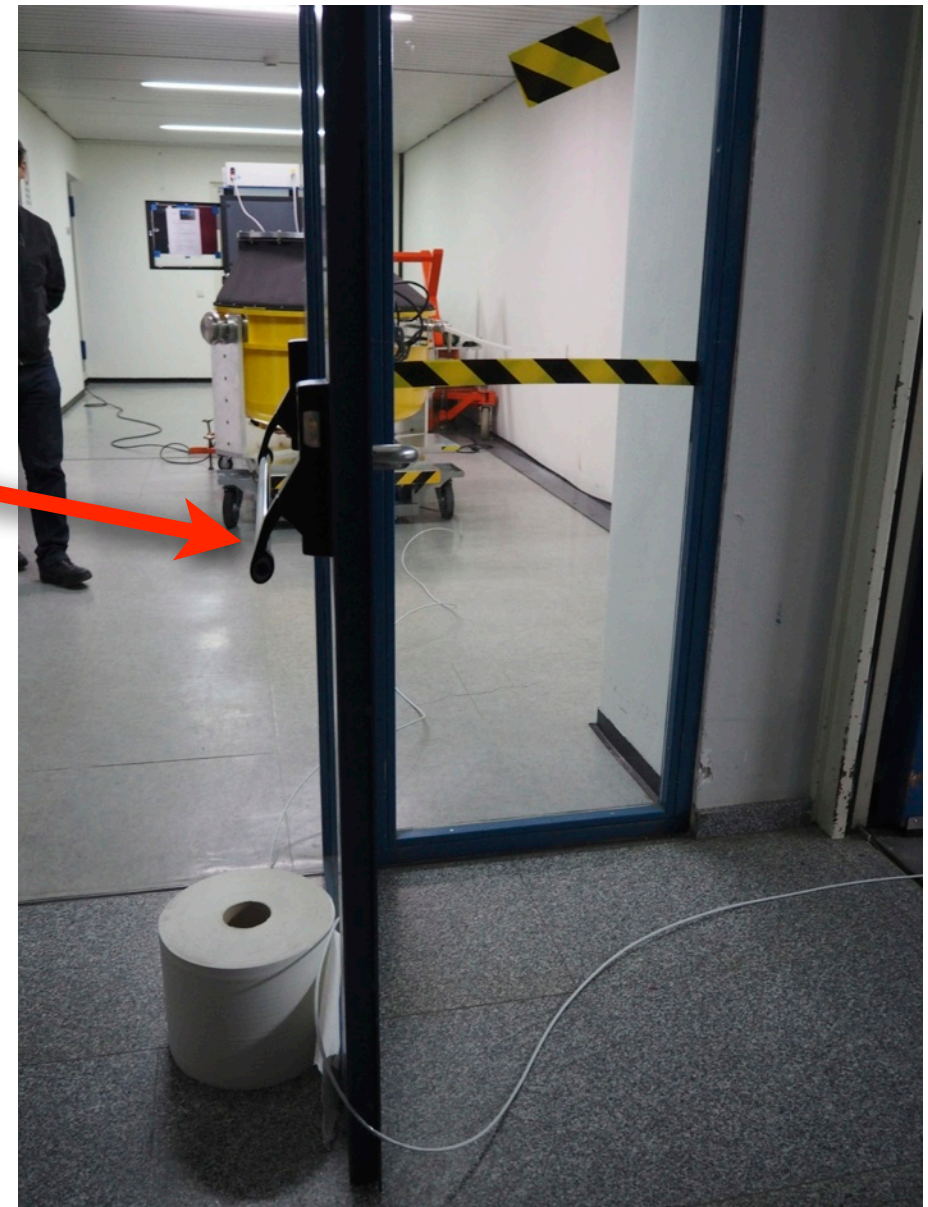
The accident: how

- Collision of pipe with panic bar (oh the irony)
- Protective bumper plate not helping

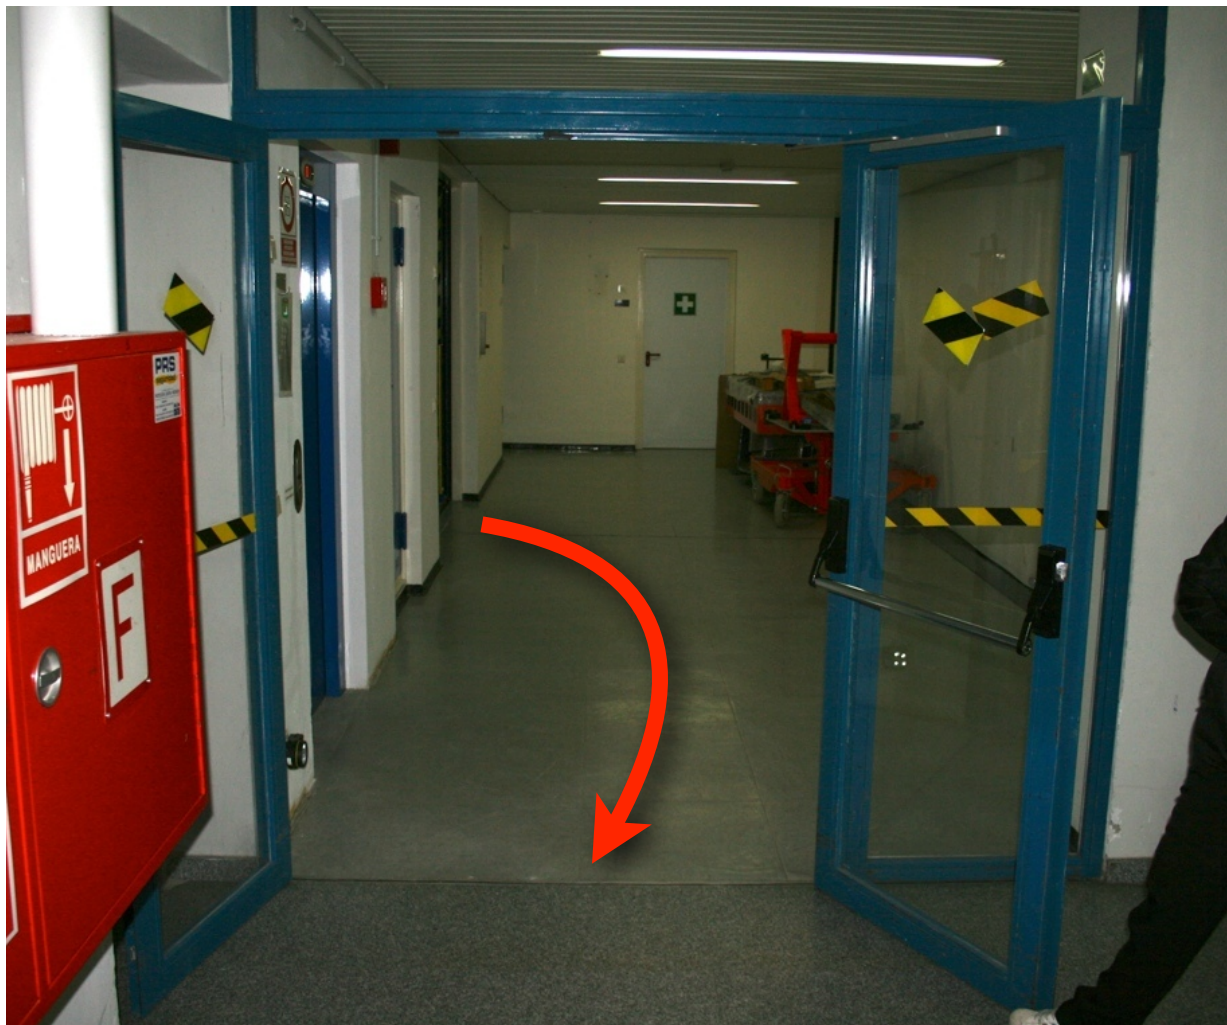
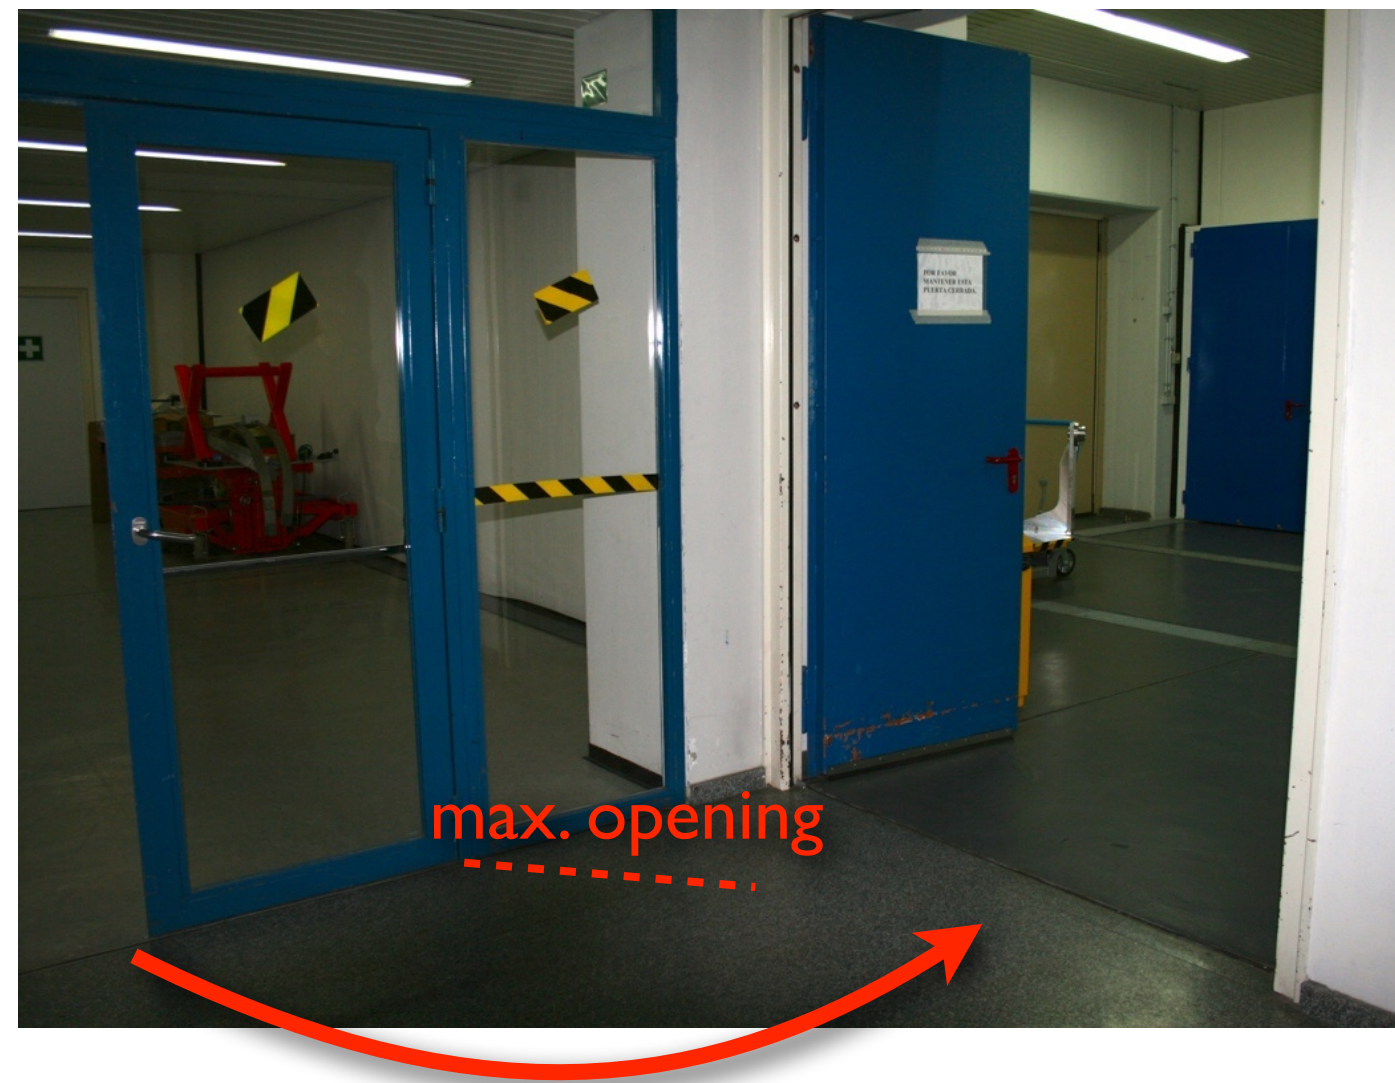
The accident: where

- After observation end: transport inside 3.5m building
- Navigation through narrow passage close to elevator

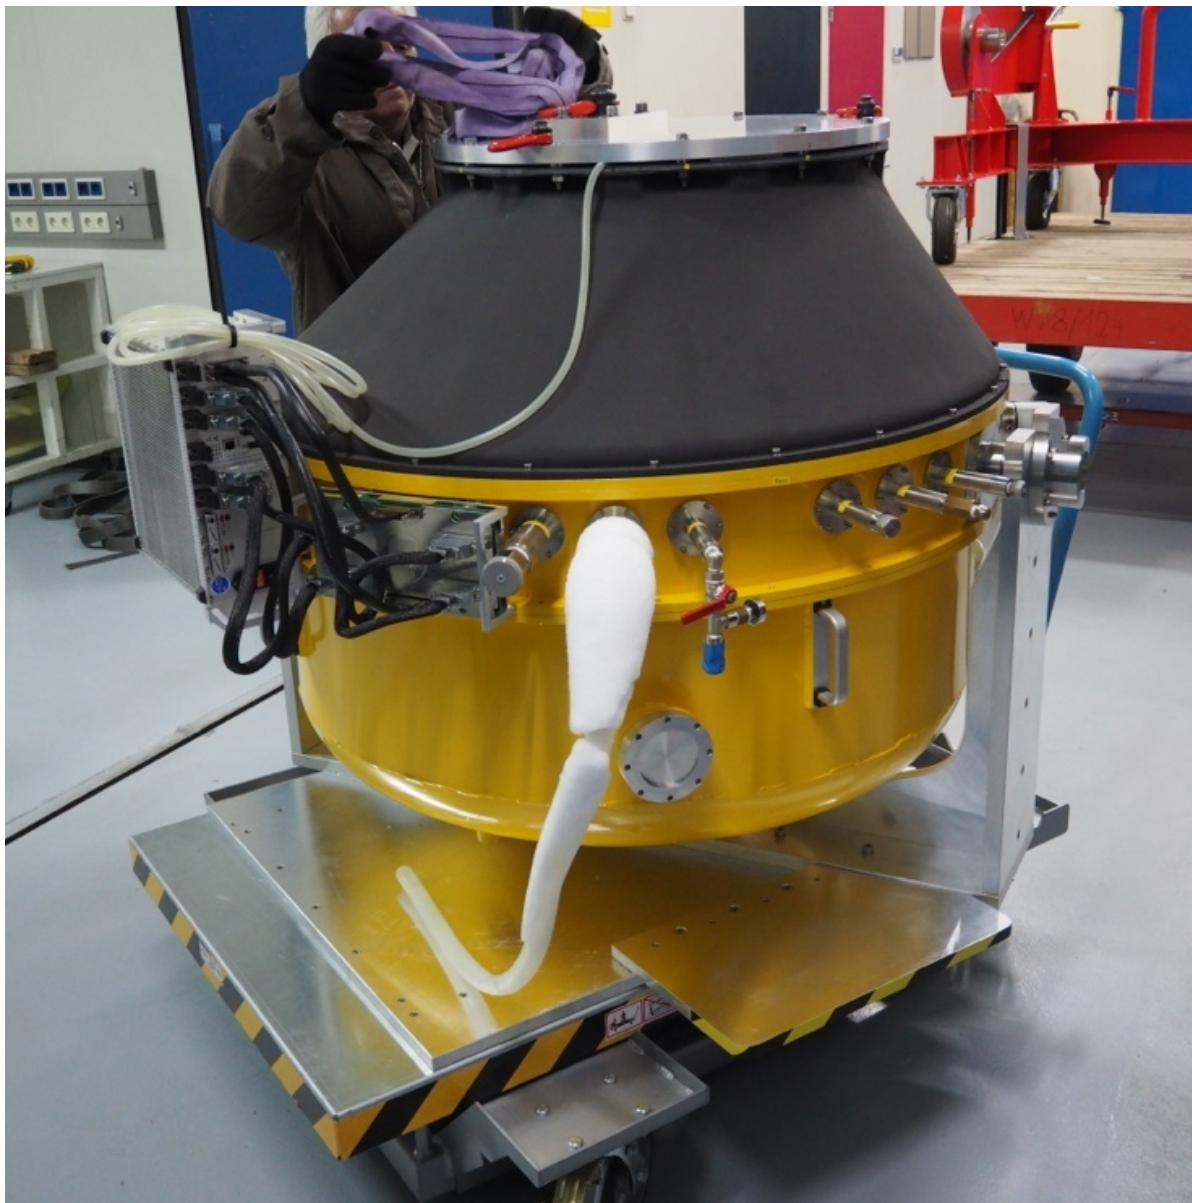
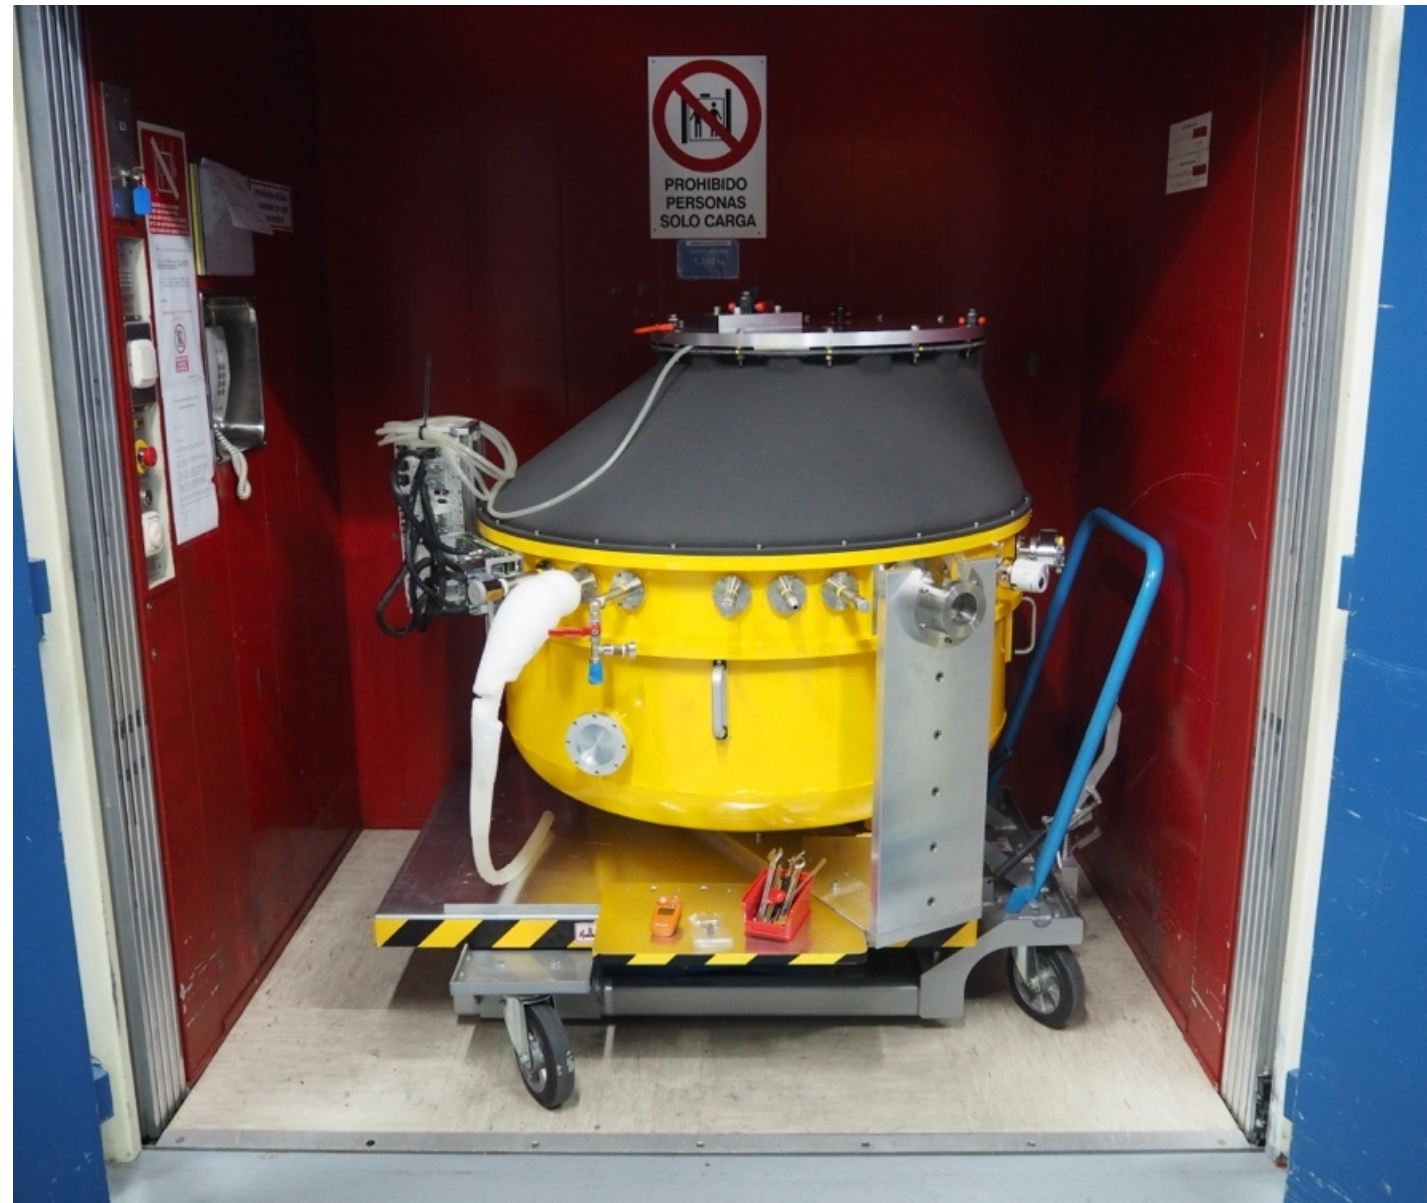
The accident: why

- Instrument always kept cold
- Telescope caddy made small to fit into 2.2m elevator

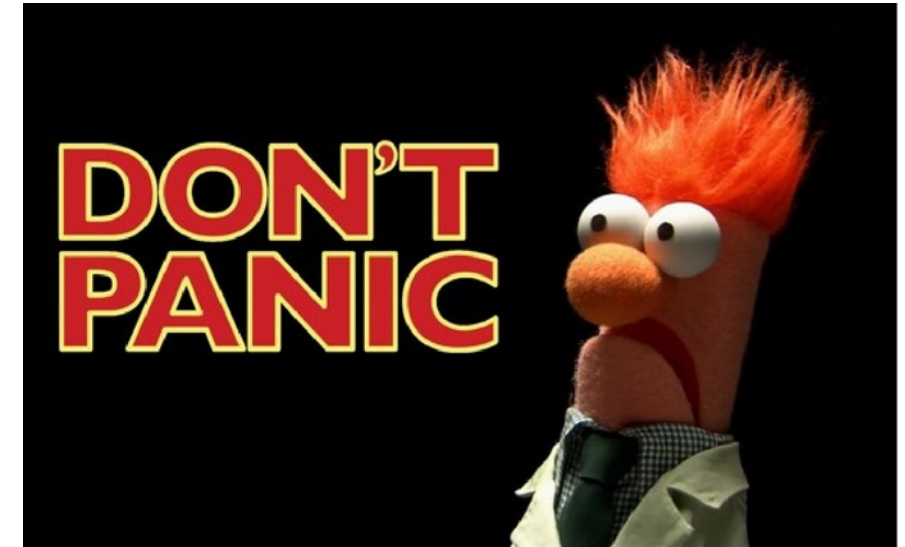
- Warming up detector with max. allowed rate: keep it warmest point in instrument
- Trying to fix leak, but lack of proper equipment: no success
- Opening would make things worse
- Wait until warmed up
- Assemble tiger team

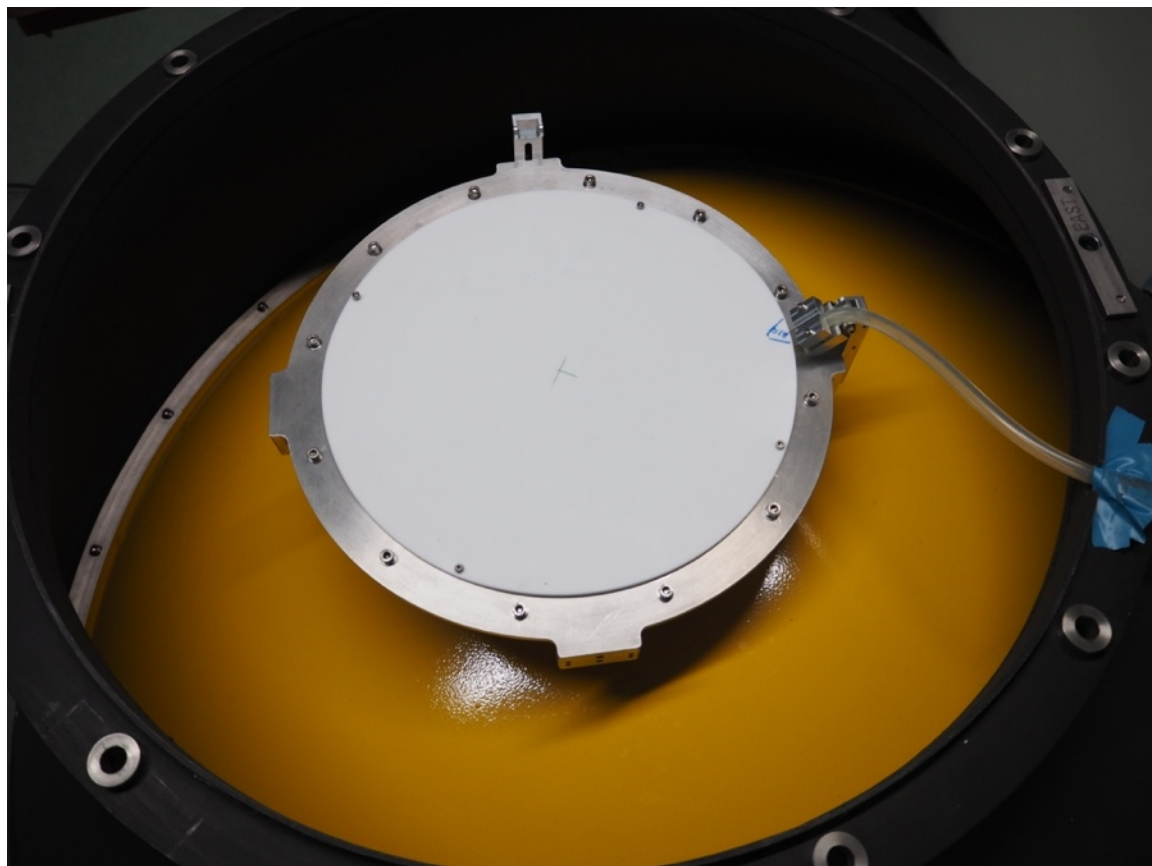
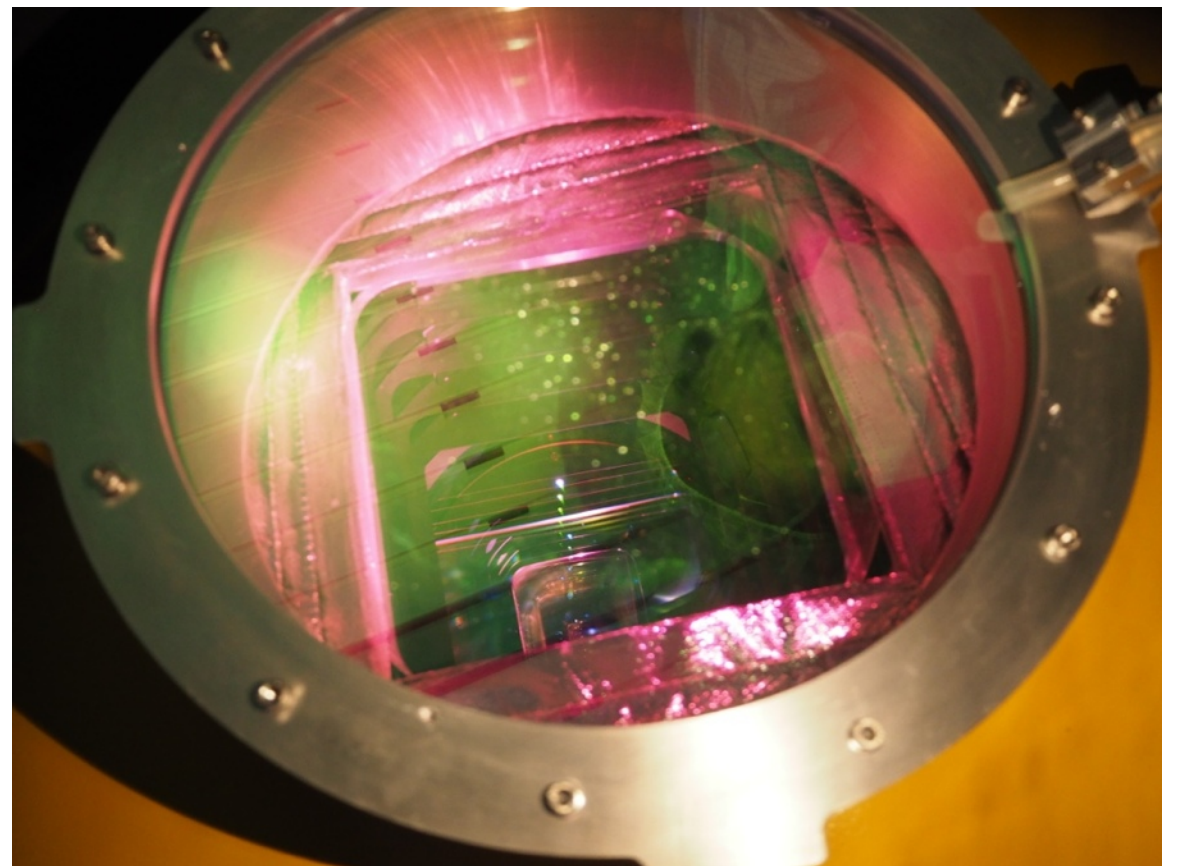
Inspection: first look

- View from telescope side: entrance window, baffles, first lens
- Passage for air to reach closed optical bench area
- No ice or condensation inside ($T \approx 265\text{K}$)

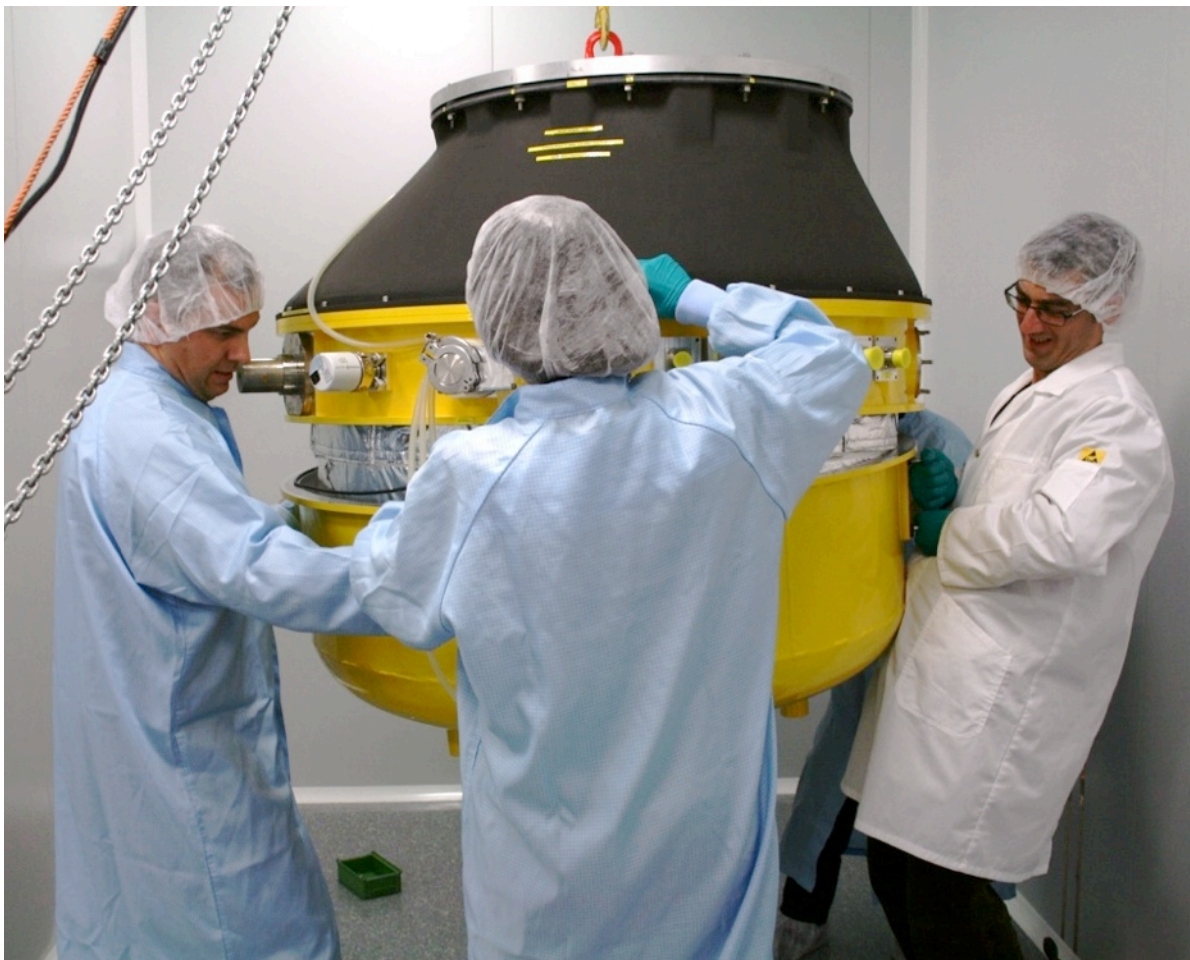
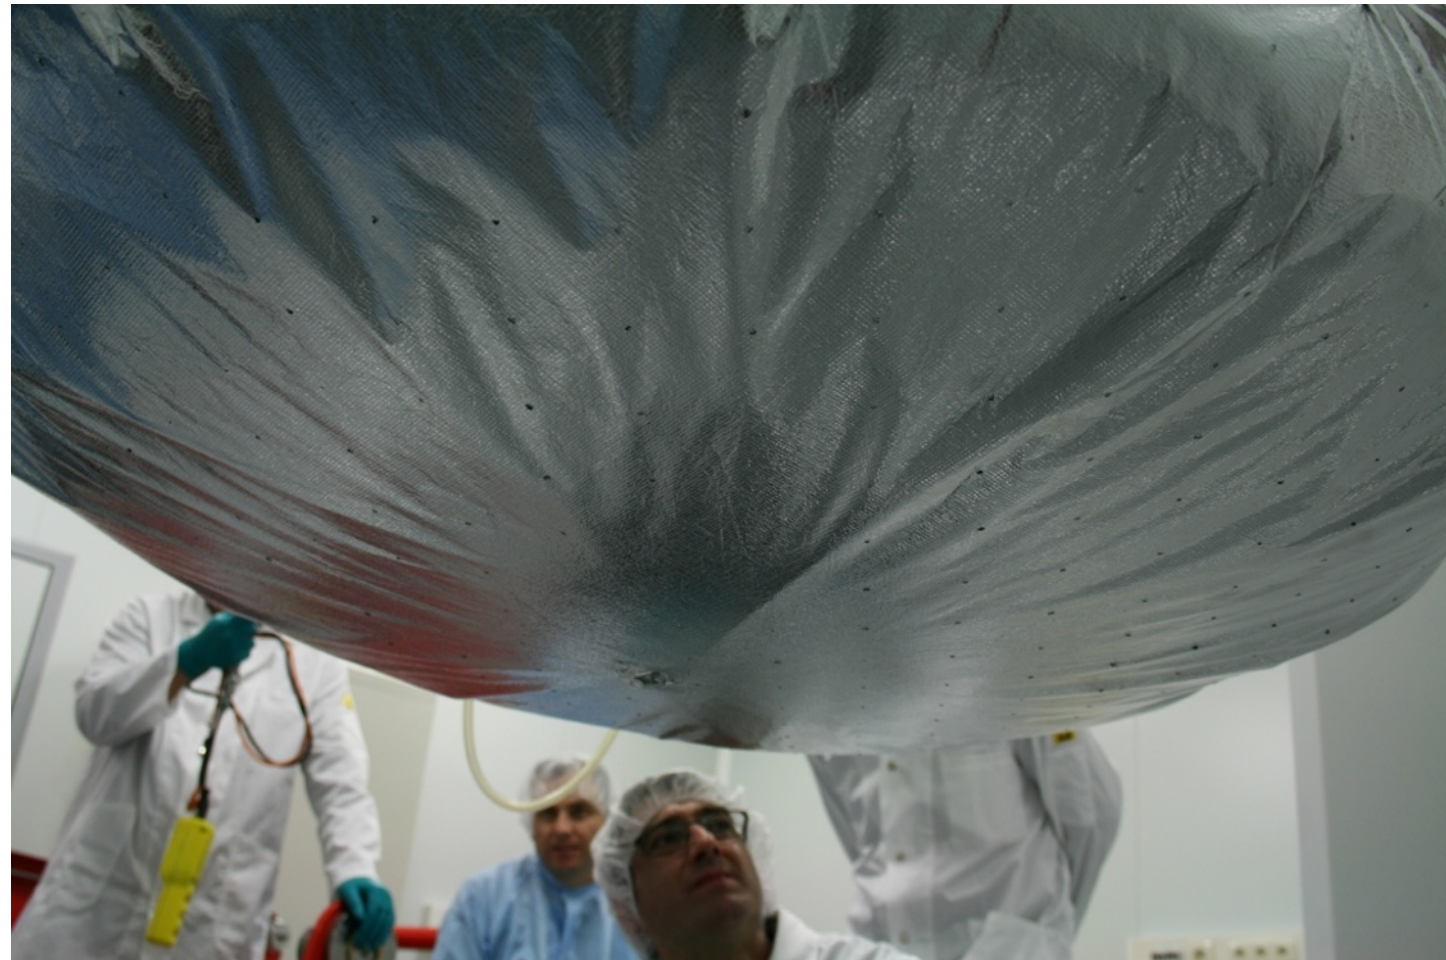
Inspection: opening

- Transport to cleanroom in 3.5m building
- Opening while hanging at crane (preserve orientation)
- No water inside cryostat hull or on radiation shield

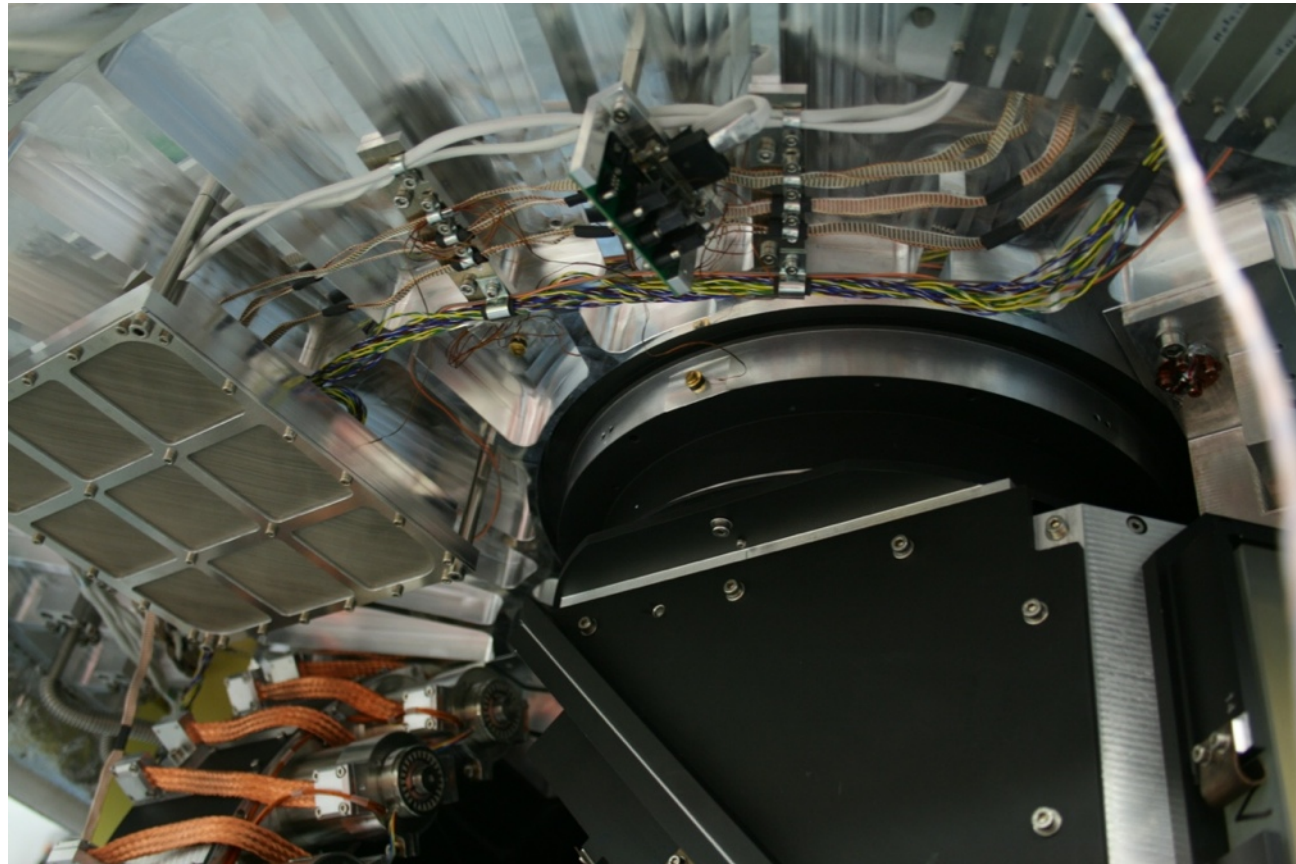
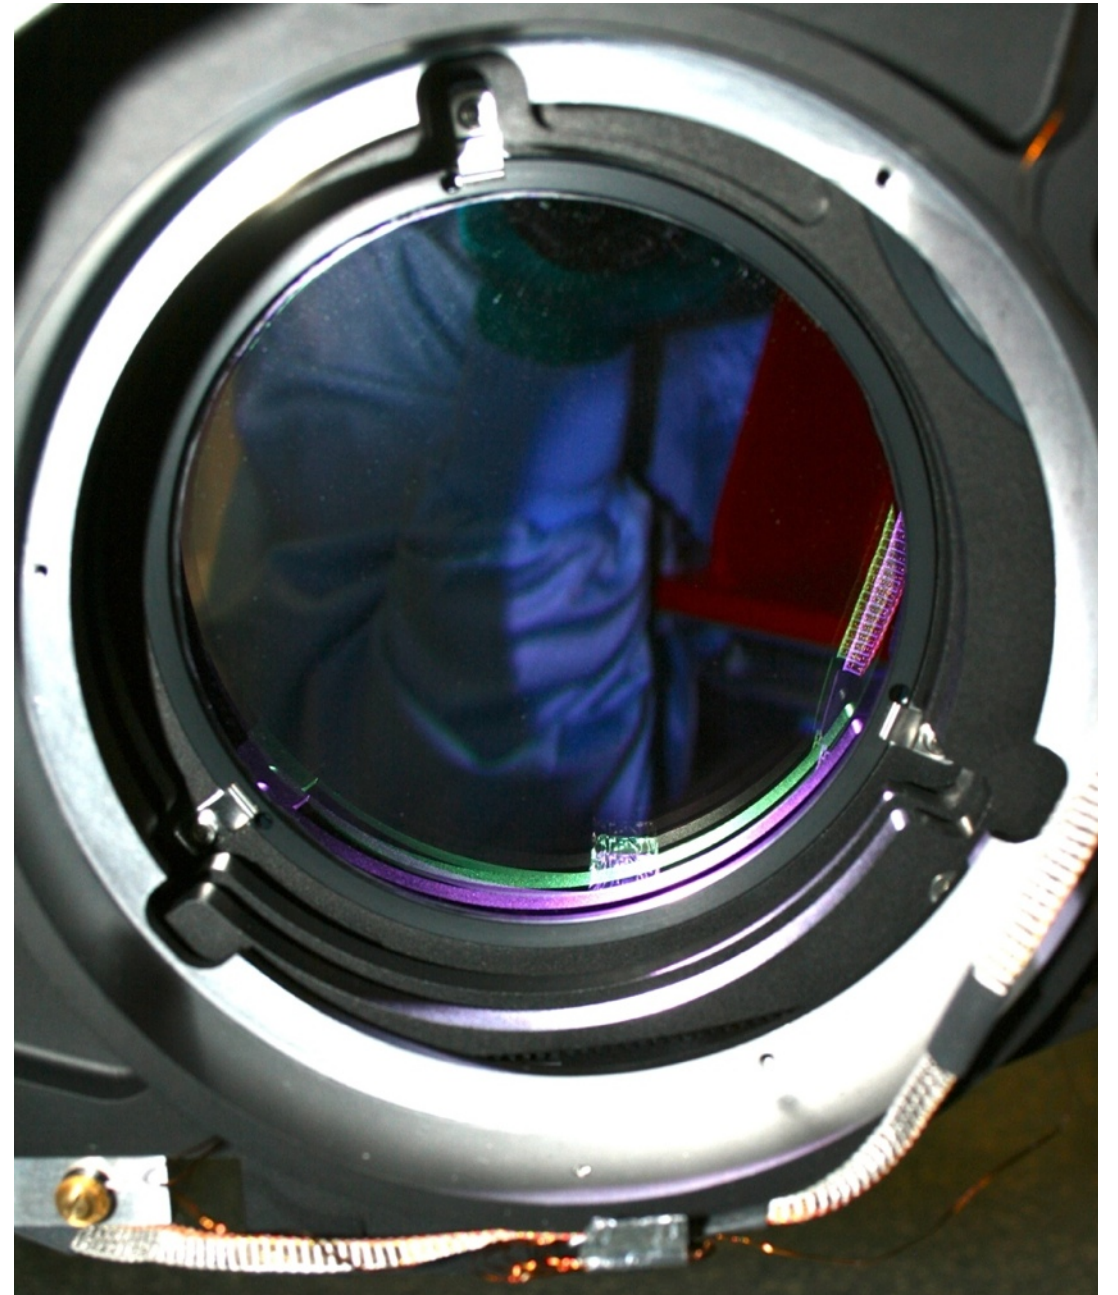
Inspection: optical bench

- Removing radiation shield
- No water anywhere to be seen
- Filters clean

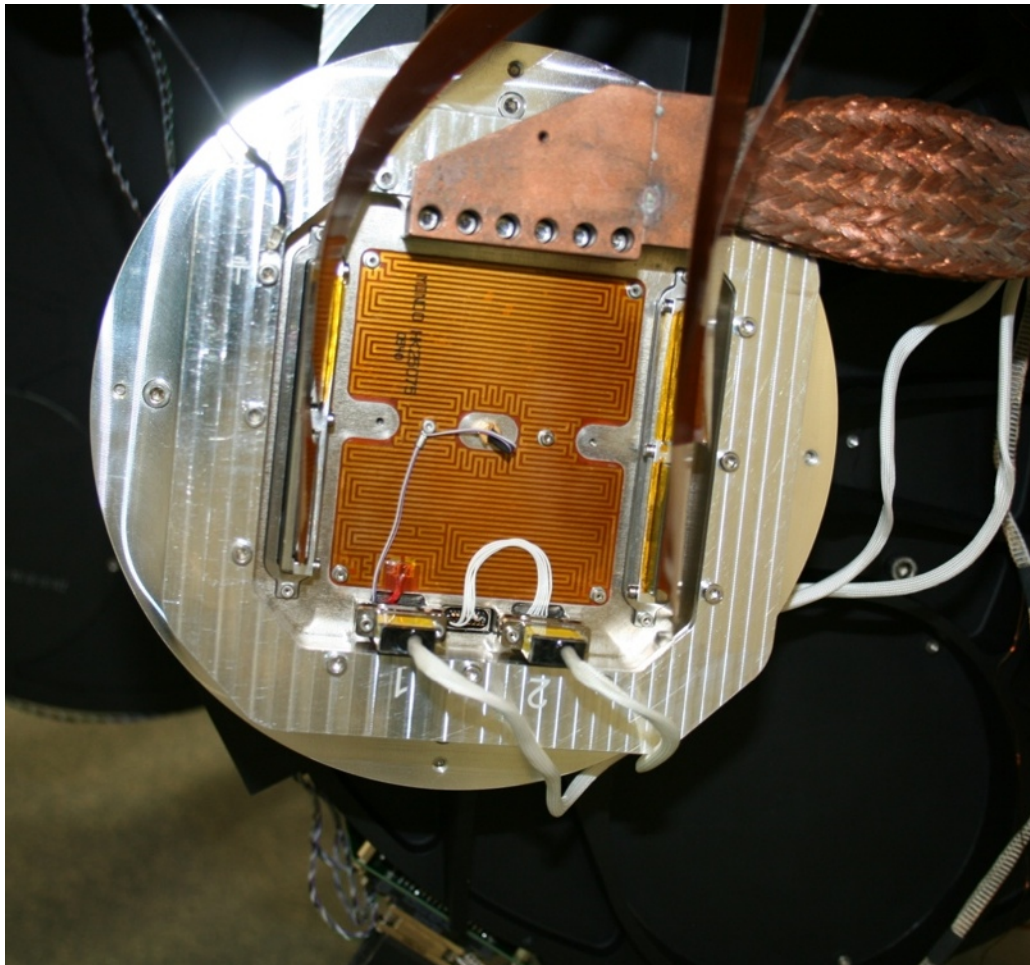
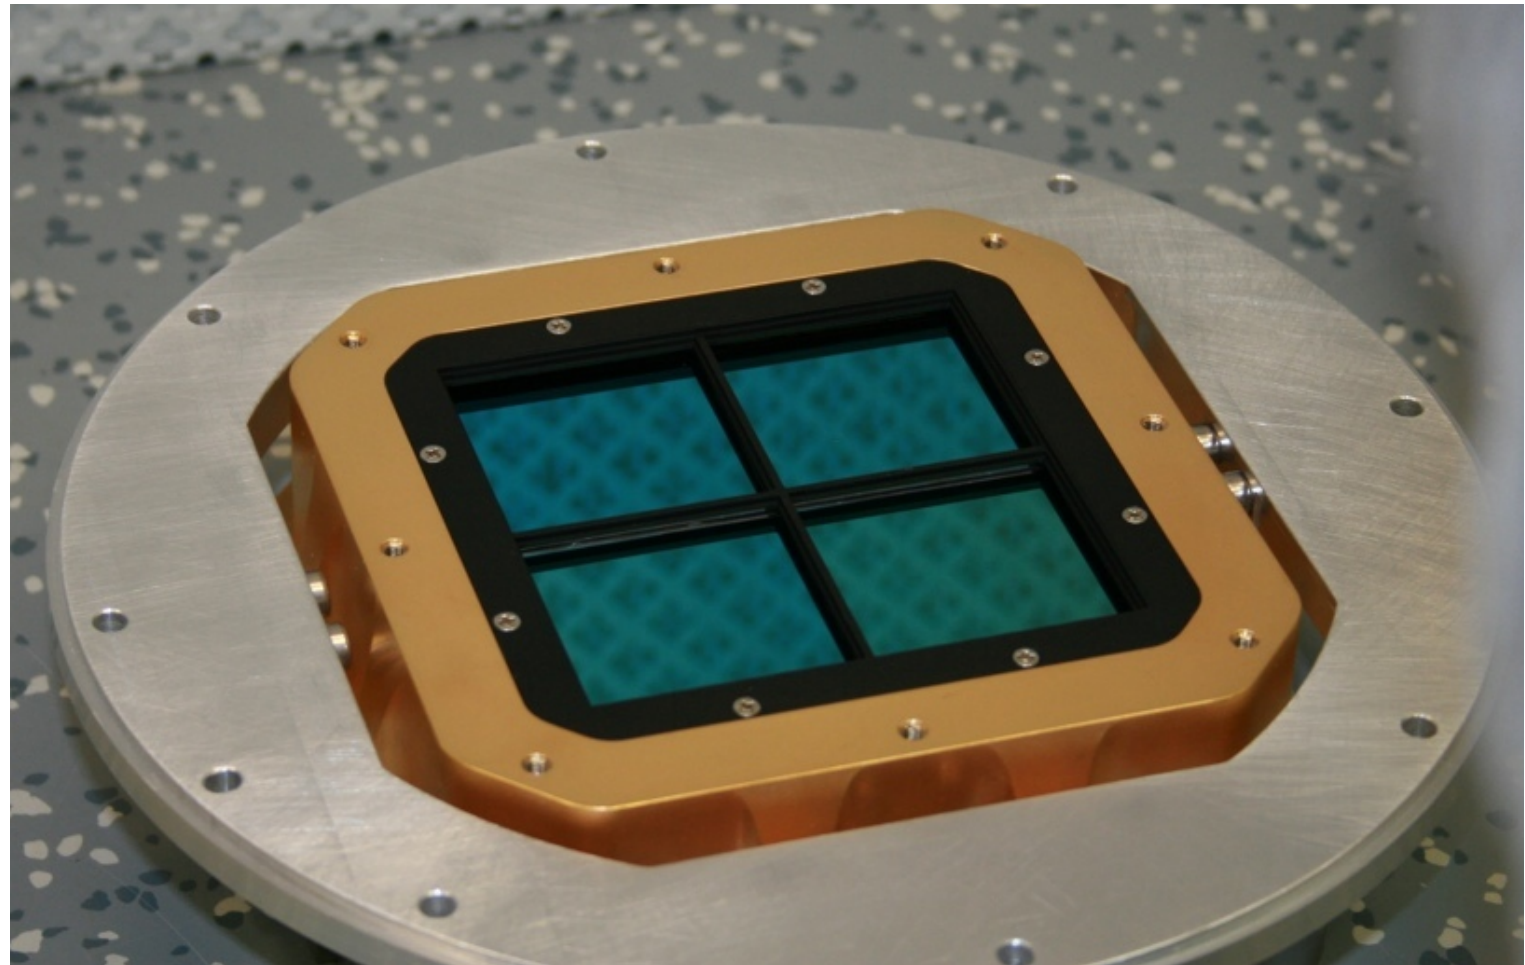
Inspection: Schrödinger's detector

- No contamination outside or on surface
- Electronics, connectors, and cables clean
