PANIC – REACTIONS AFTER CRYOSTAT LEAK

Bernhard Dorner, 27 March 2015
MPIA AstroTechTalk

The accident: what

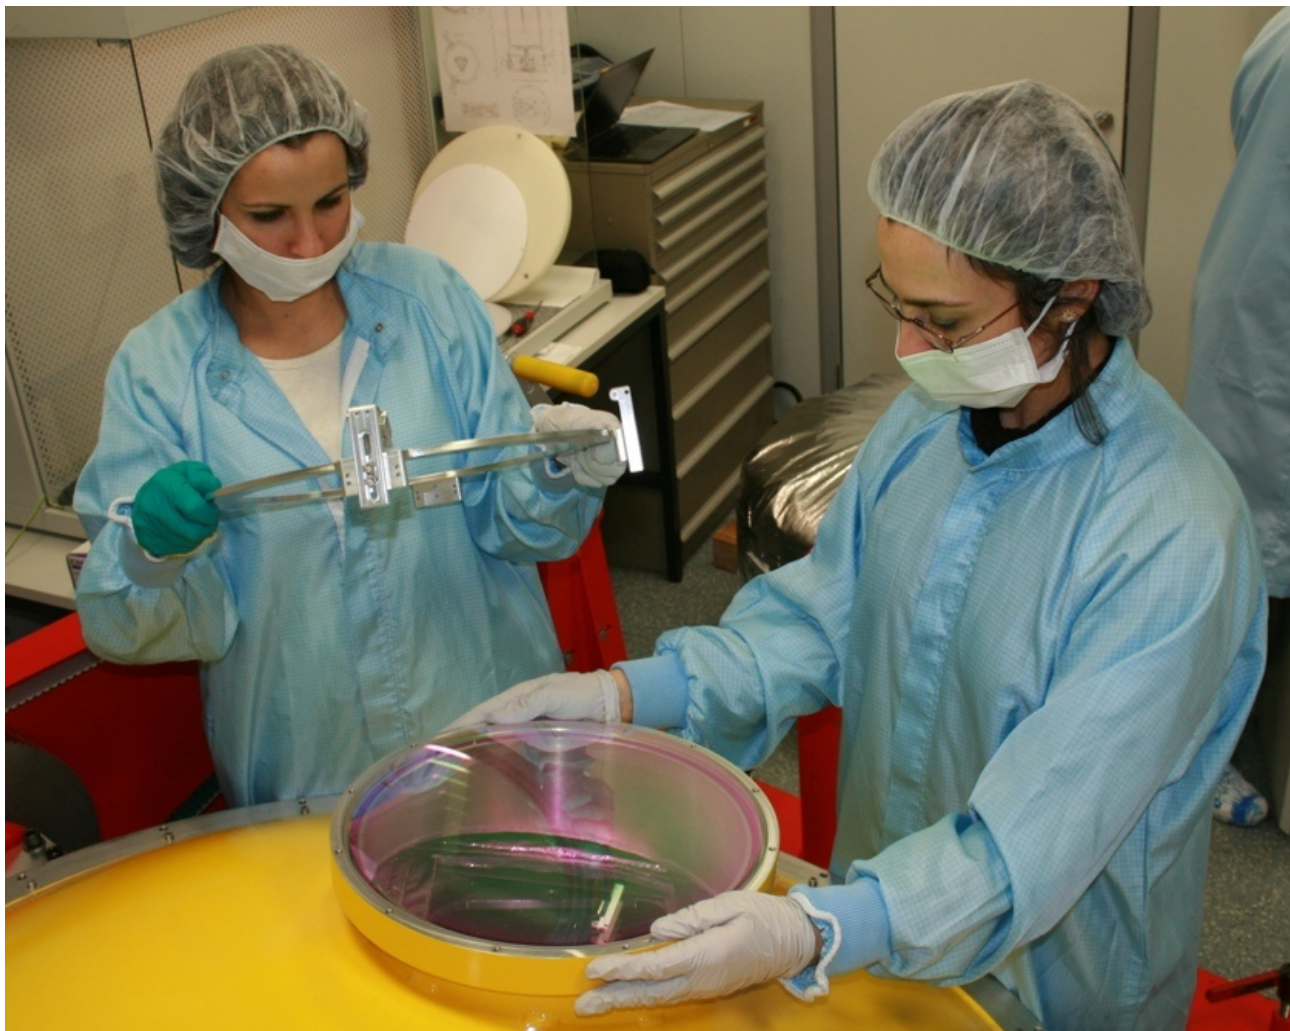
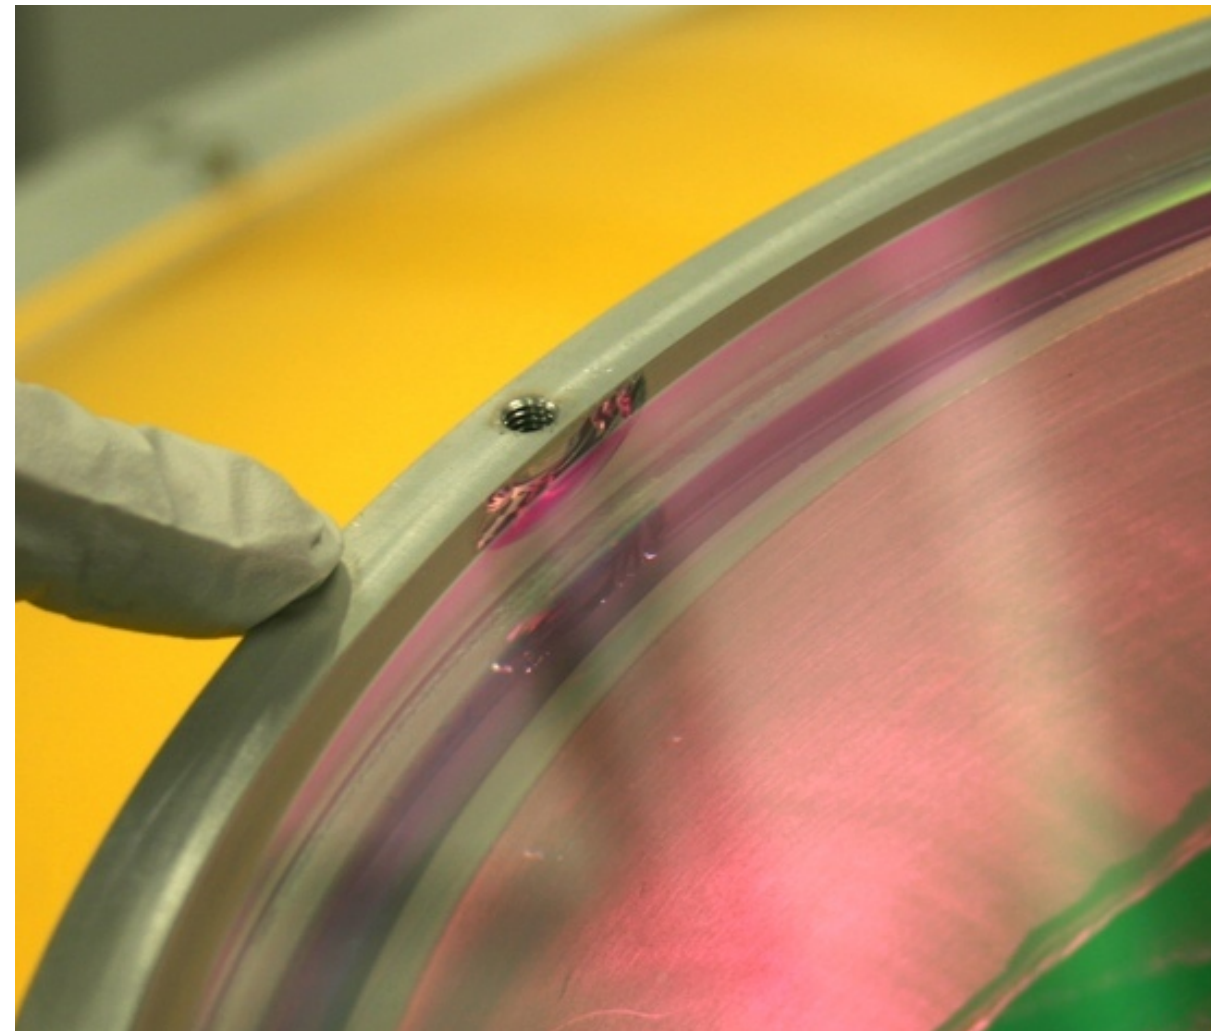
Inspection: Entrance window

- Routine disassembly for cleaning
- Volume crack found near edge outside of vacuum seal
- Connection with accident unlikely

- Just kicked off work
- Try to re-polish edge?
- Examine mechanical arrangement of seal and holding ring, improve mounting

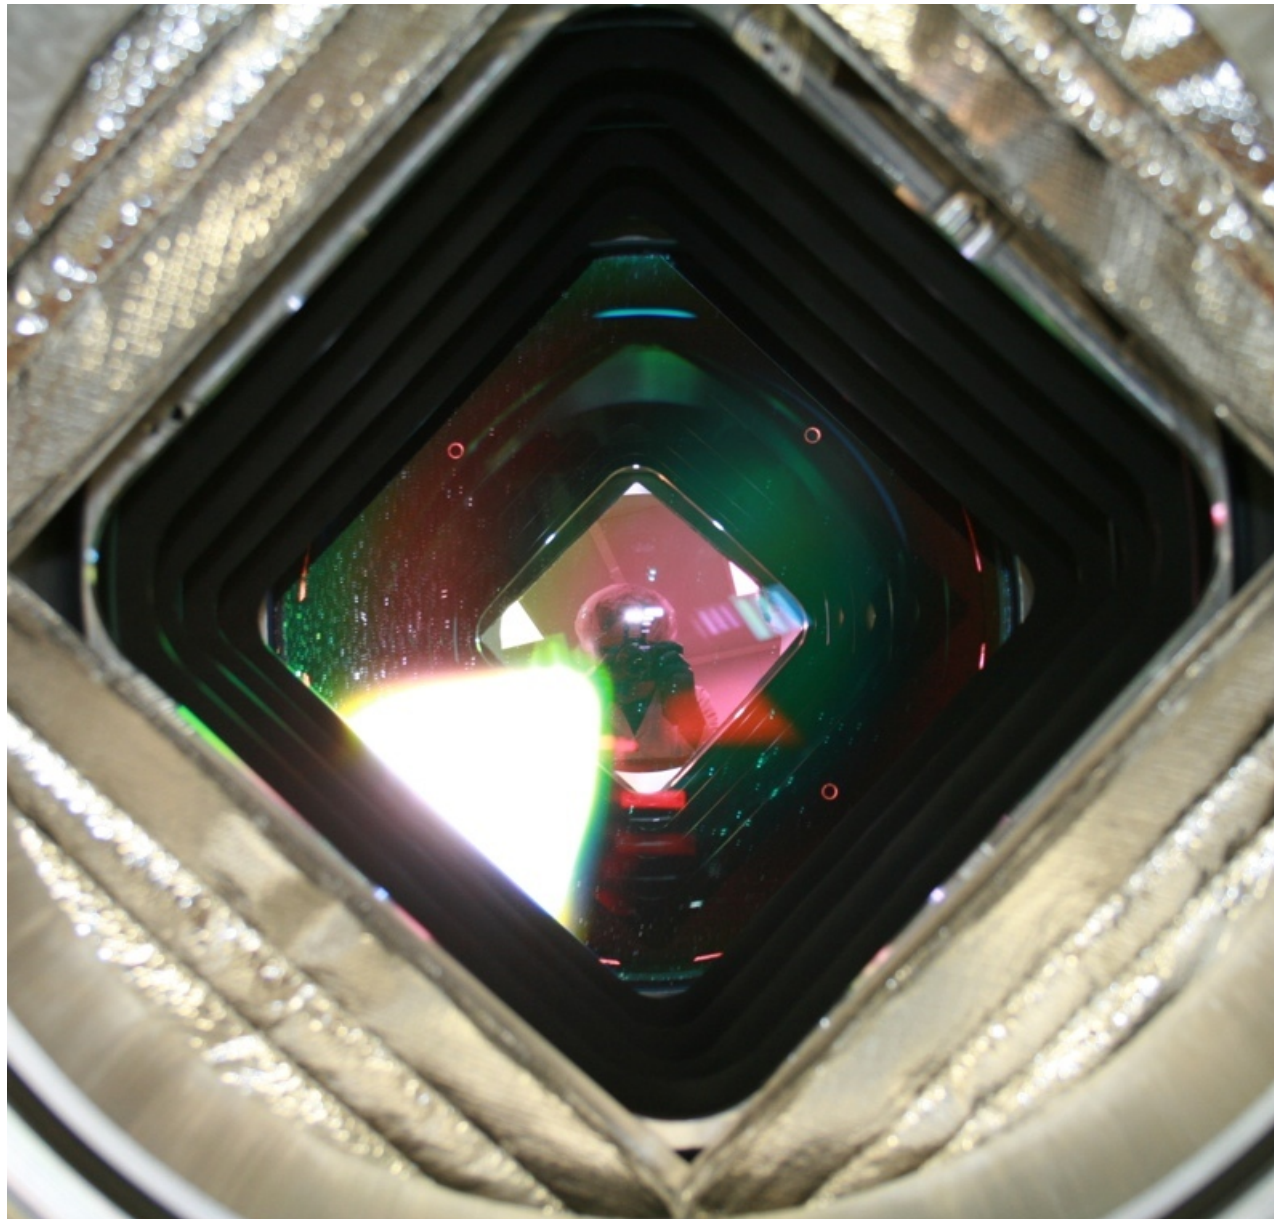
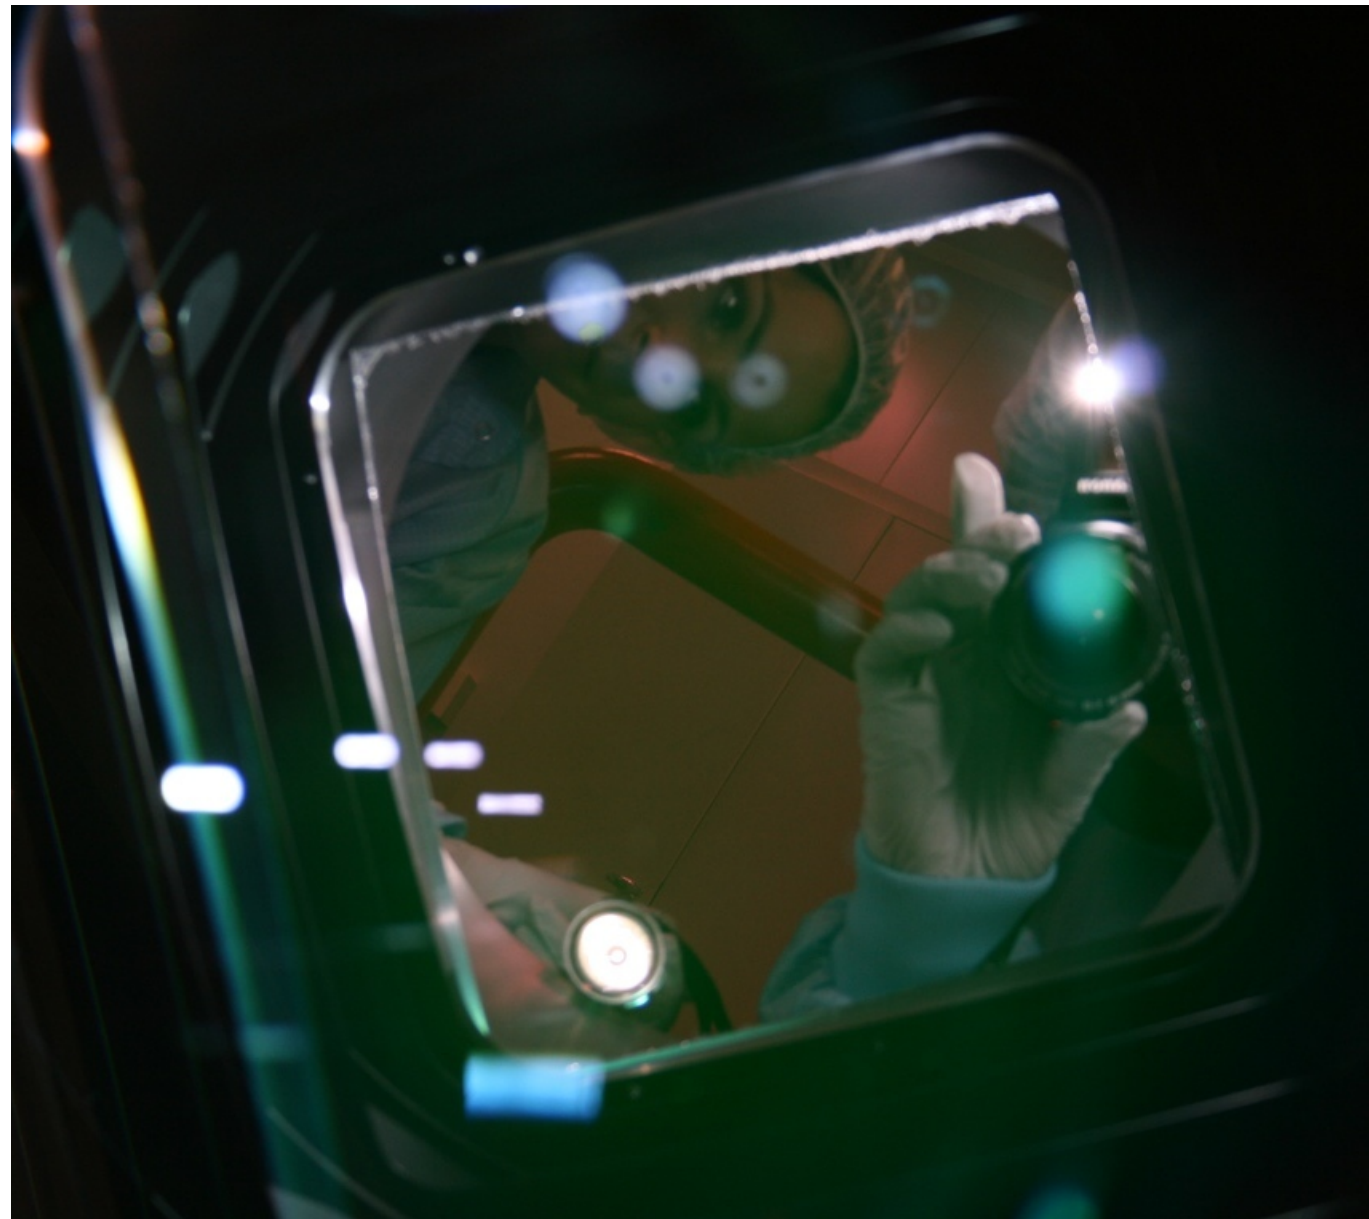
Inspection: First lens

- Some contamination on outer surface
- Origin unknown, cleaning successful

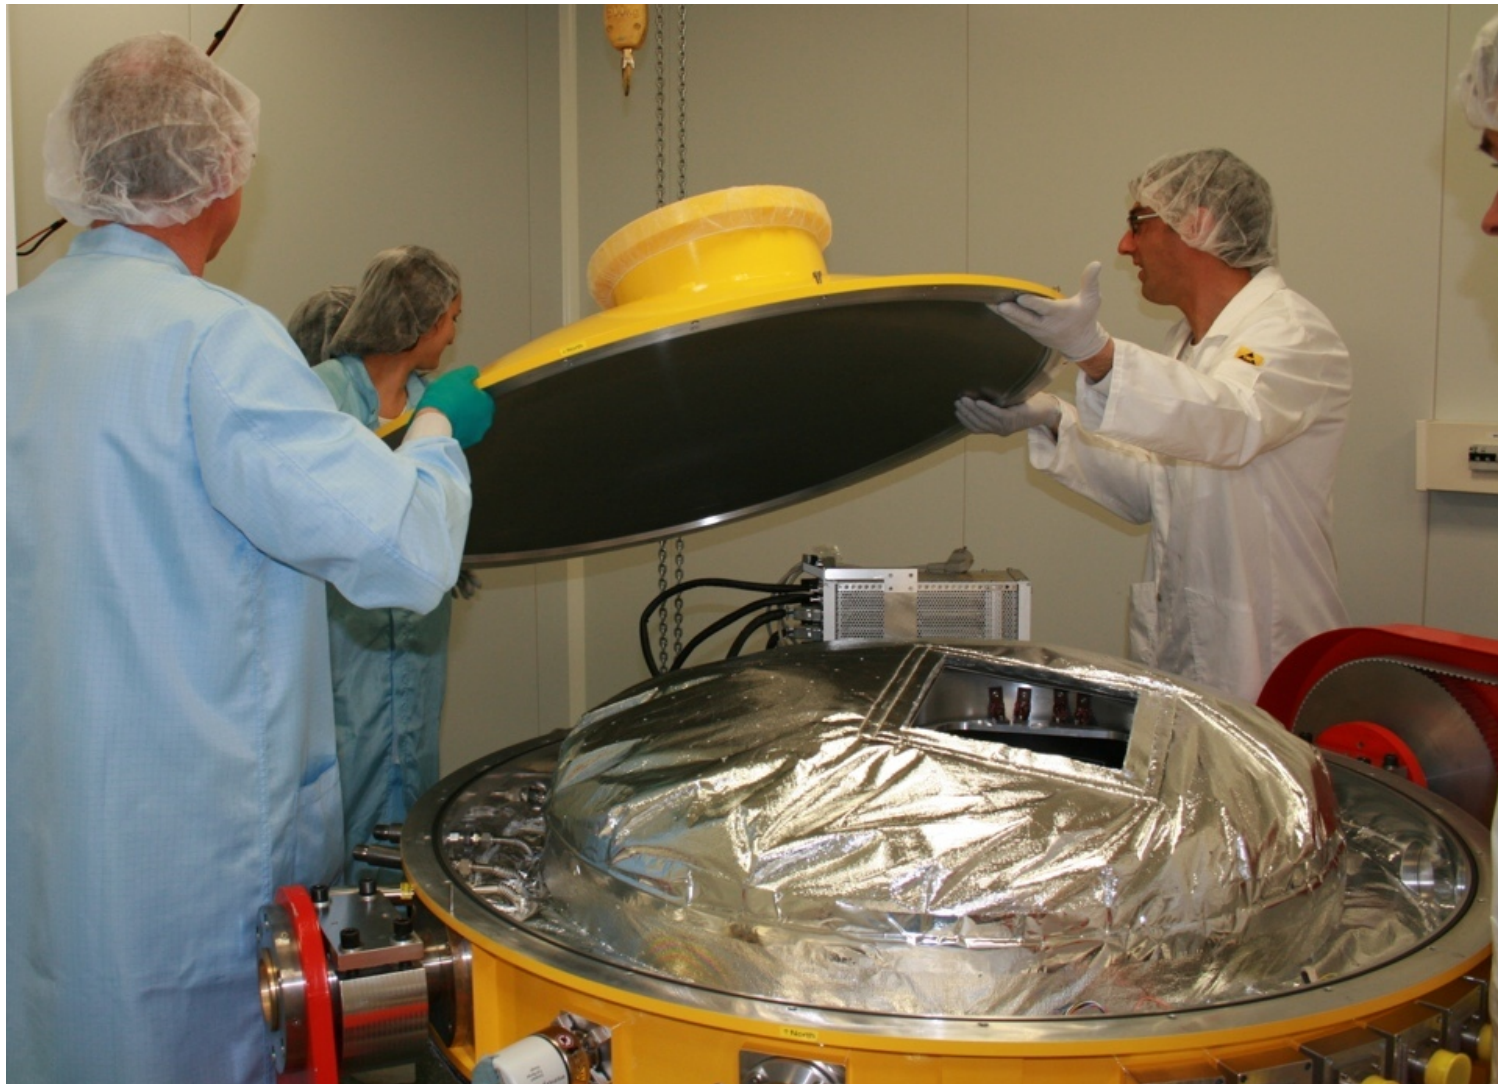
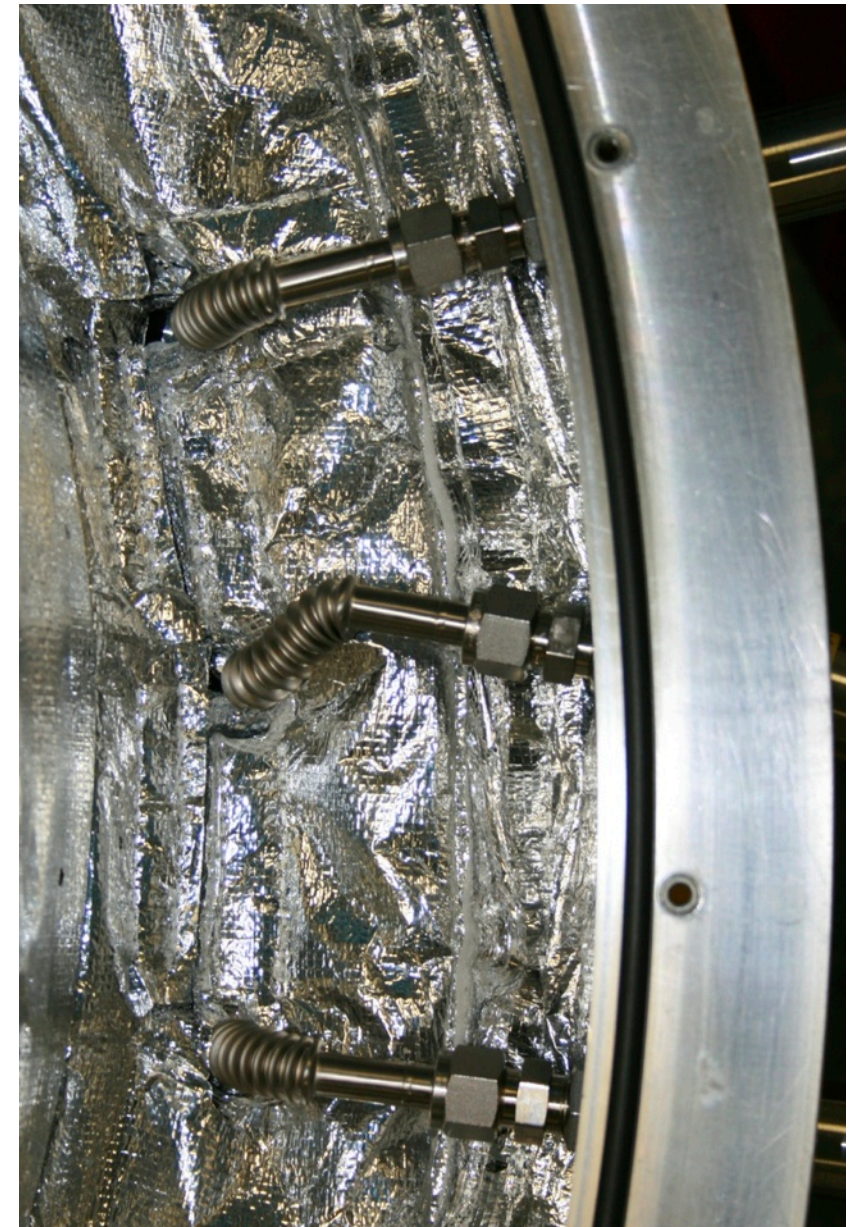
Inspection: Pipes

- Opening cryostat from telescope side
- Exhaust pipe bent, parts until bench need replacement

- Parts on backorder, delivery mid April

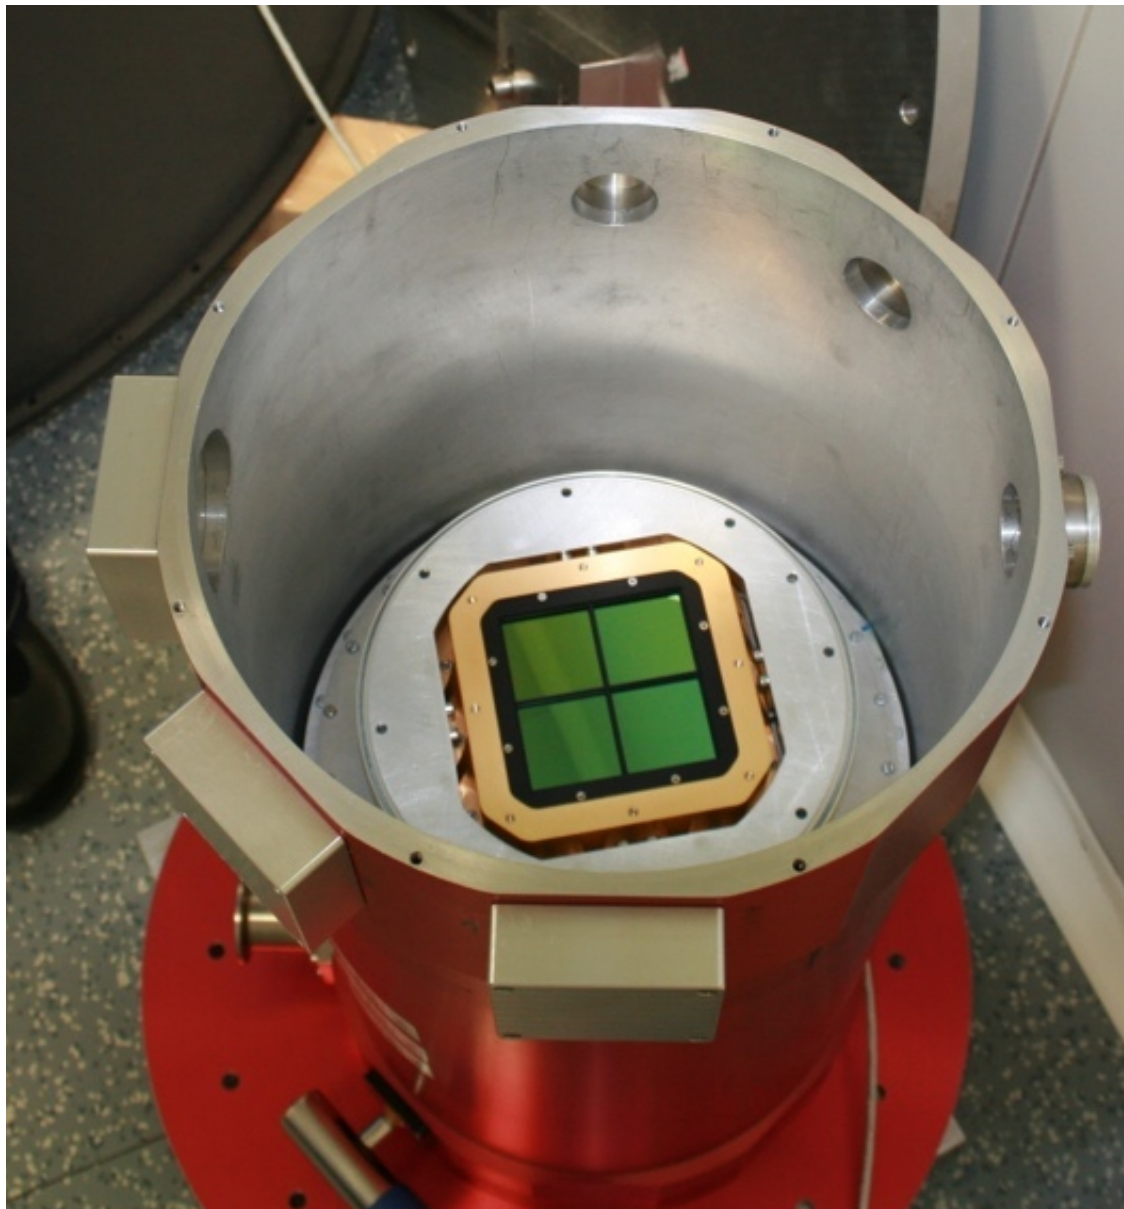
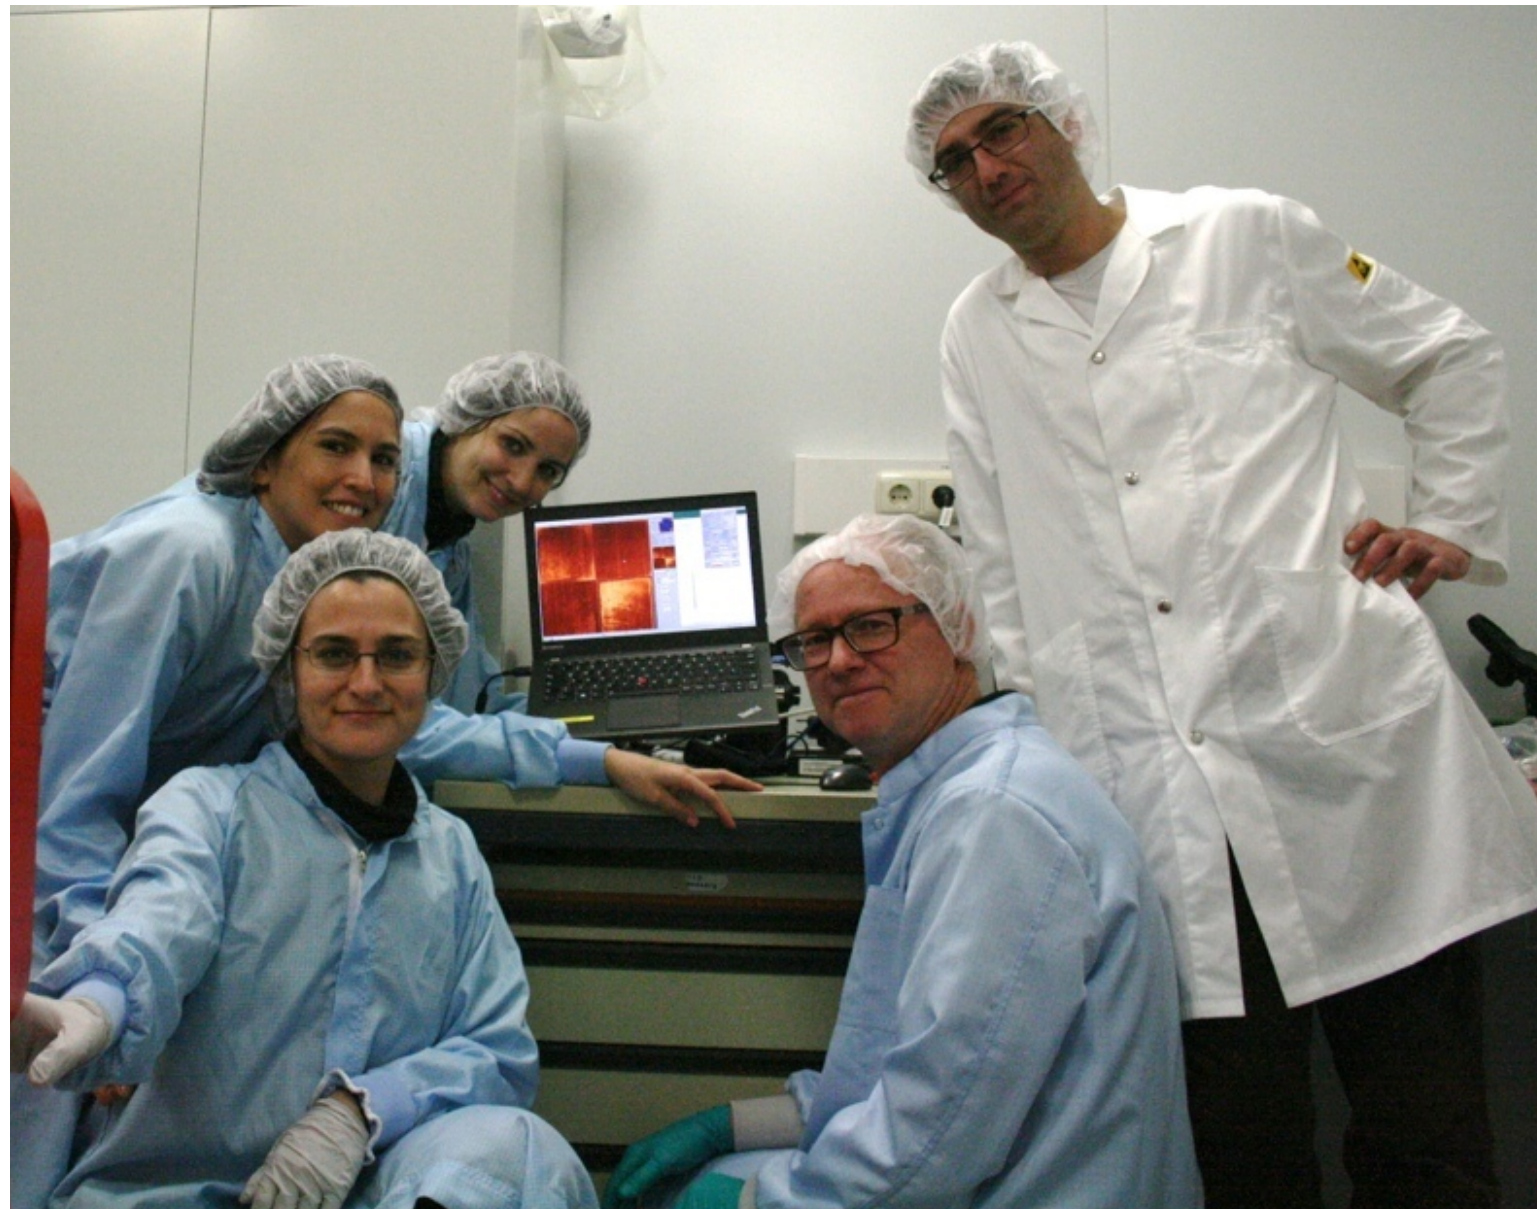
Detector recovery

- Pump over night to remove water or contaminants
- Re-Install and warm functional test: successful!

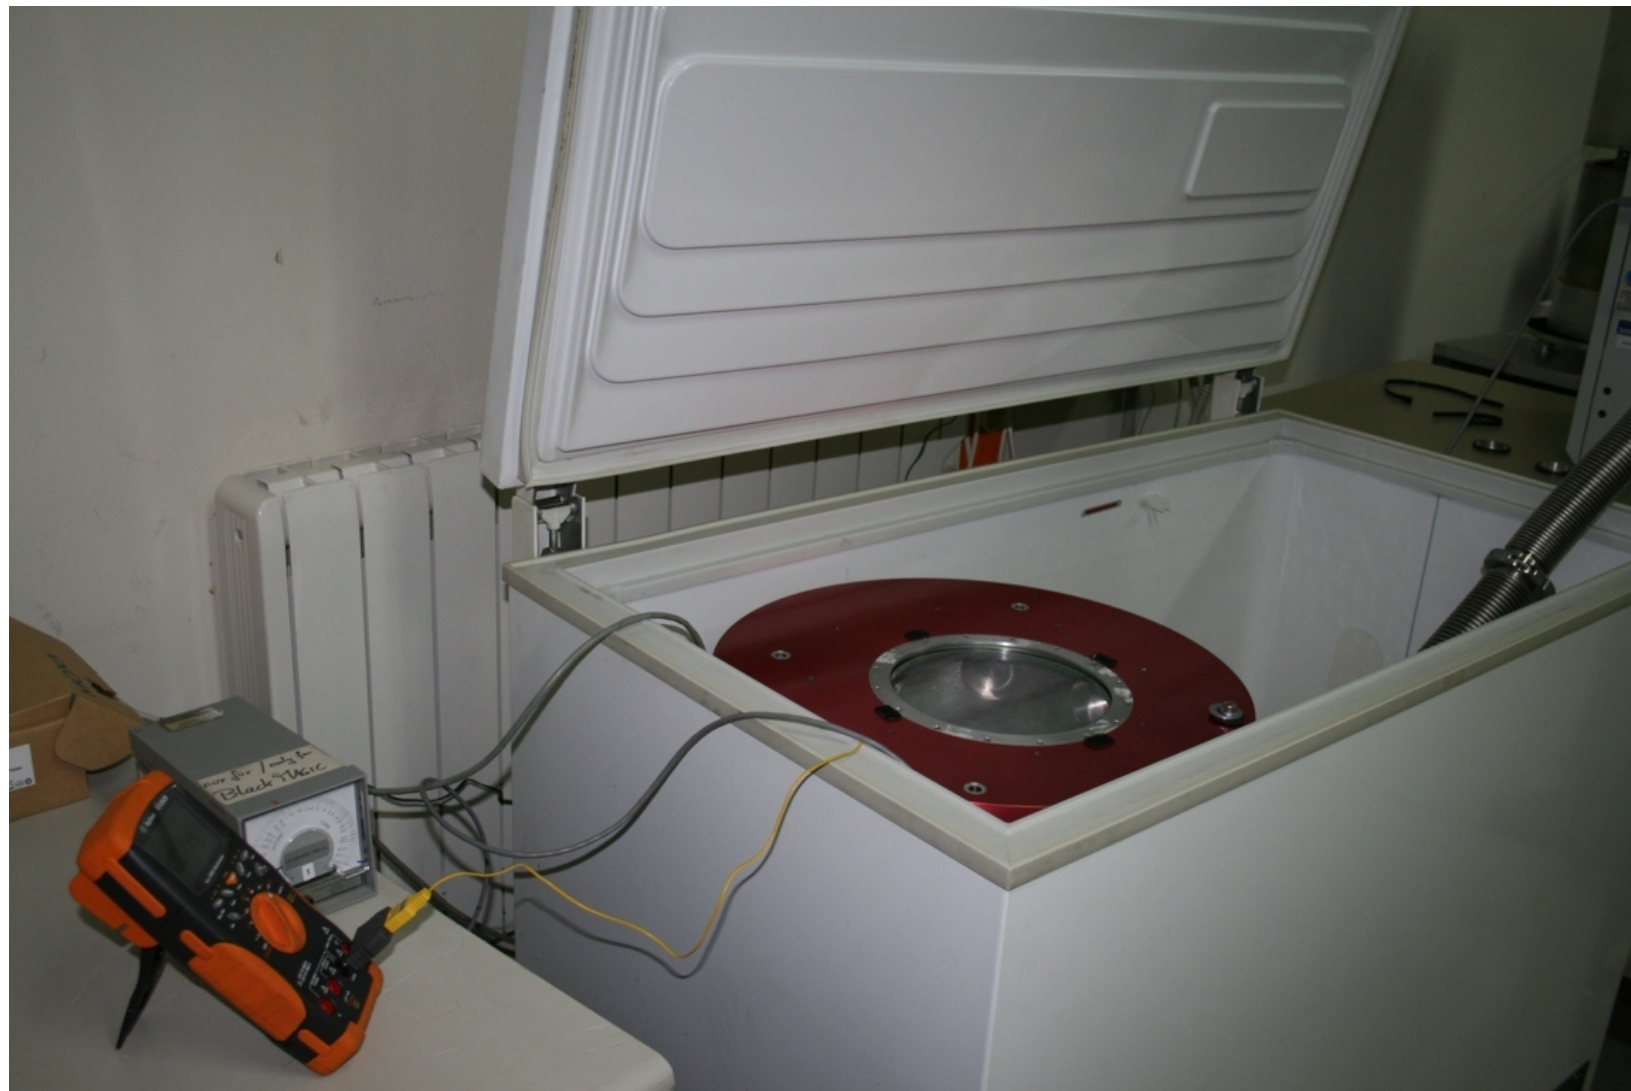
Closeout

- Detector put in vacuum, stored in freezer (-26°C)
- Entrance window replaced with metal dummy
- Cryostat closed and left in cleanroom

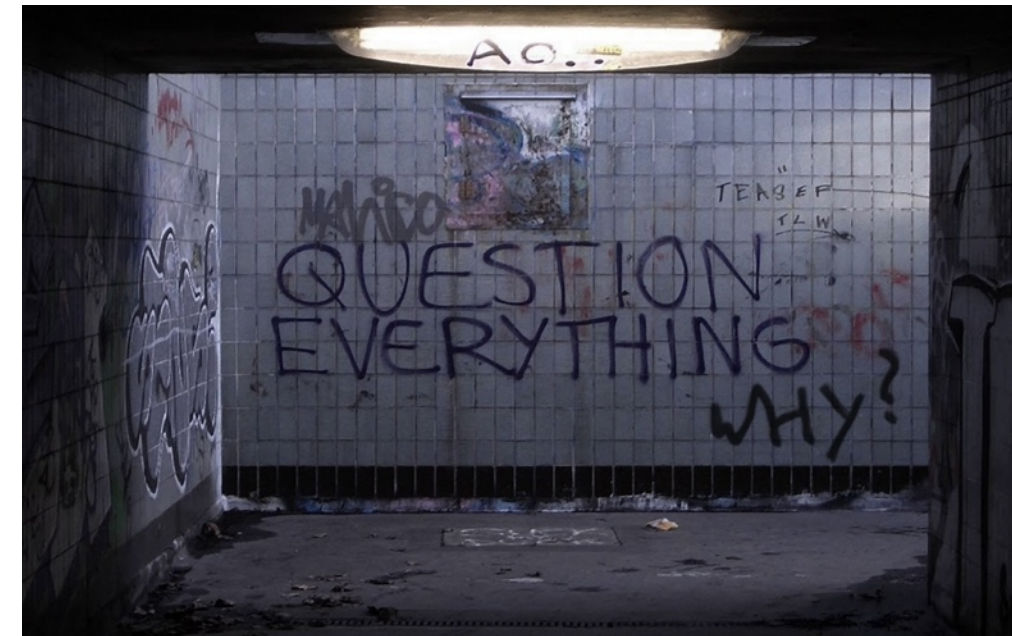
- Optical
 - ▶ Star simulator at warm by eye: nothing strange
 - ▶ Real test at cold with detector
- Detector
 - ▶ Routine lab tests for noise and hot pixels
 - ▶ At telescope: throughput and flatfield response
